**Subject: Transmittal of Phase II Environmental Site Assessment
Former GAF Facility
218 Bayfront Parkway
Erie, Pennsylvania 16507**

**PHASE II ENVIRONMENTAL
SITE ASSESSMENT**

**GAF BUILDING MATERIALS CORPORATION, INC. SITE
218 West Bayfront Parkway
Erie, Pennsylvania 16507**

Erie County Convention Center Authority

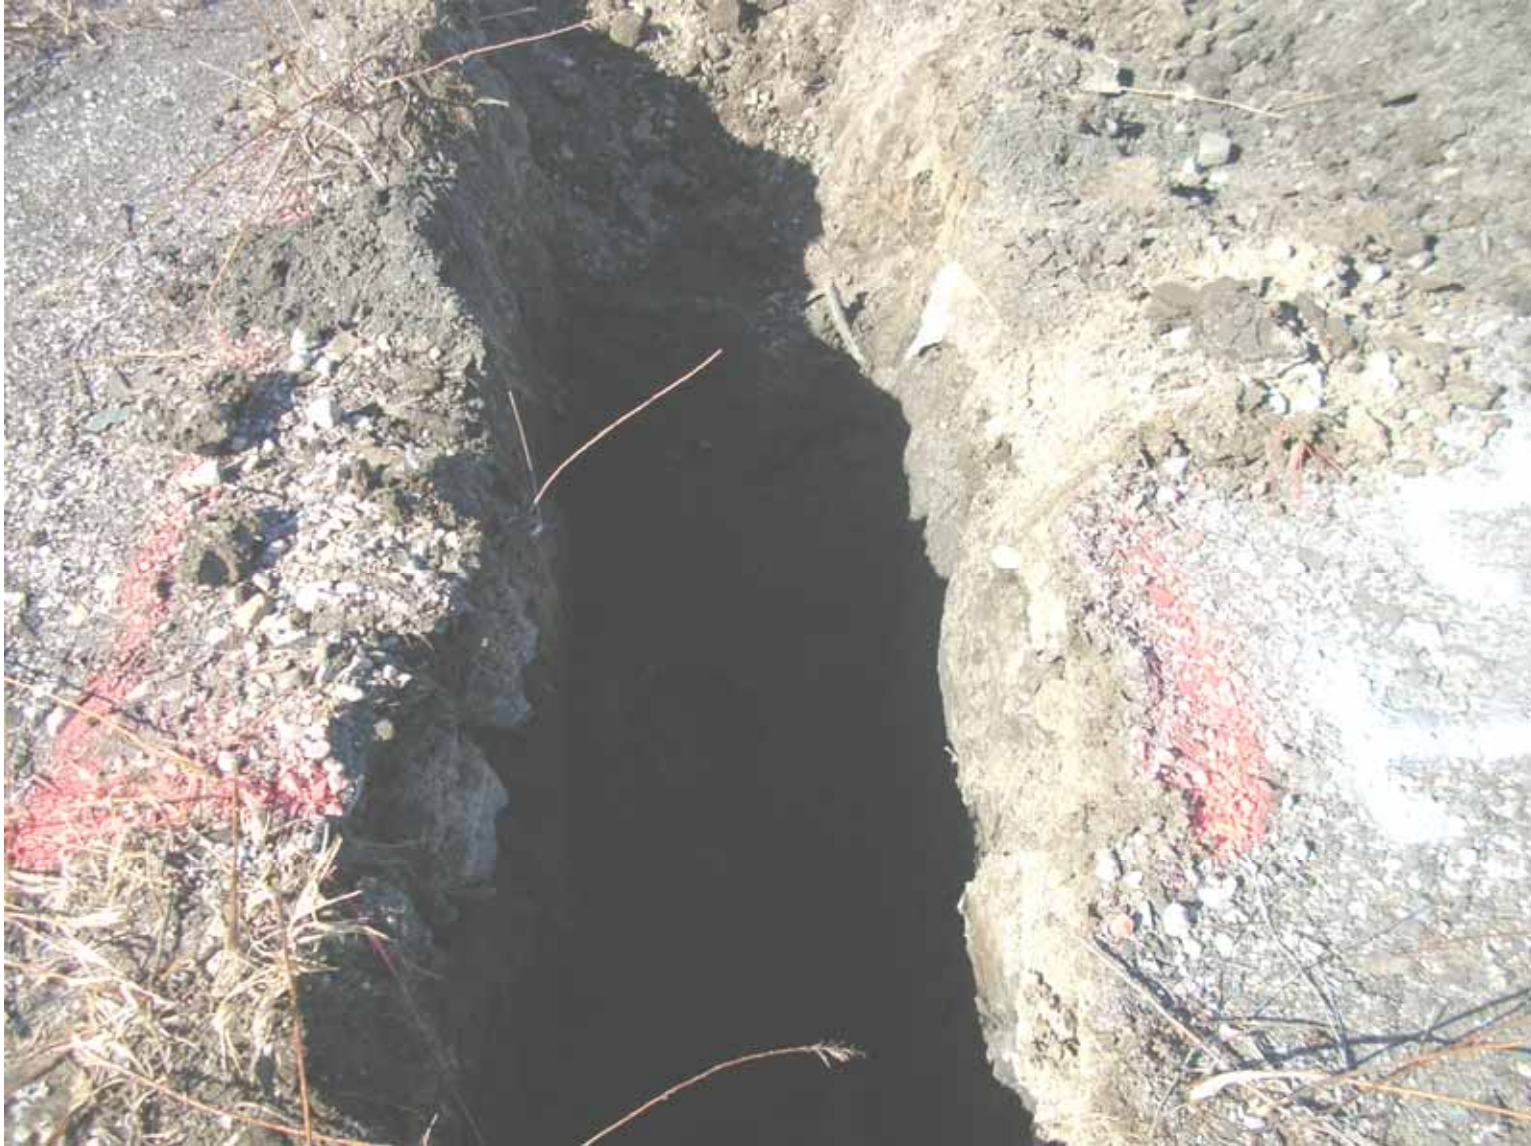
Test Pit TP-1

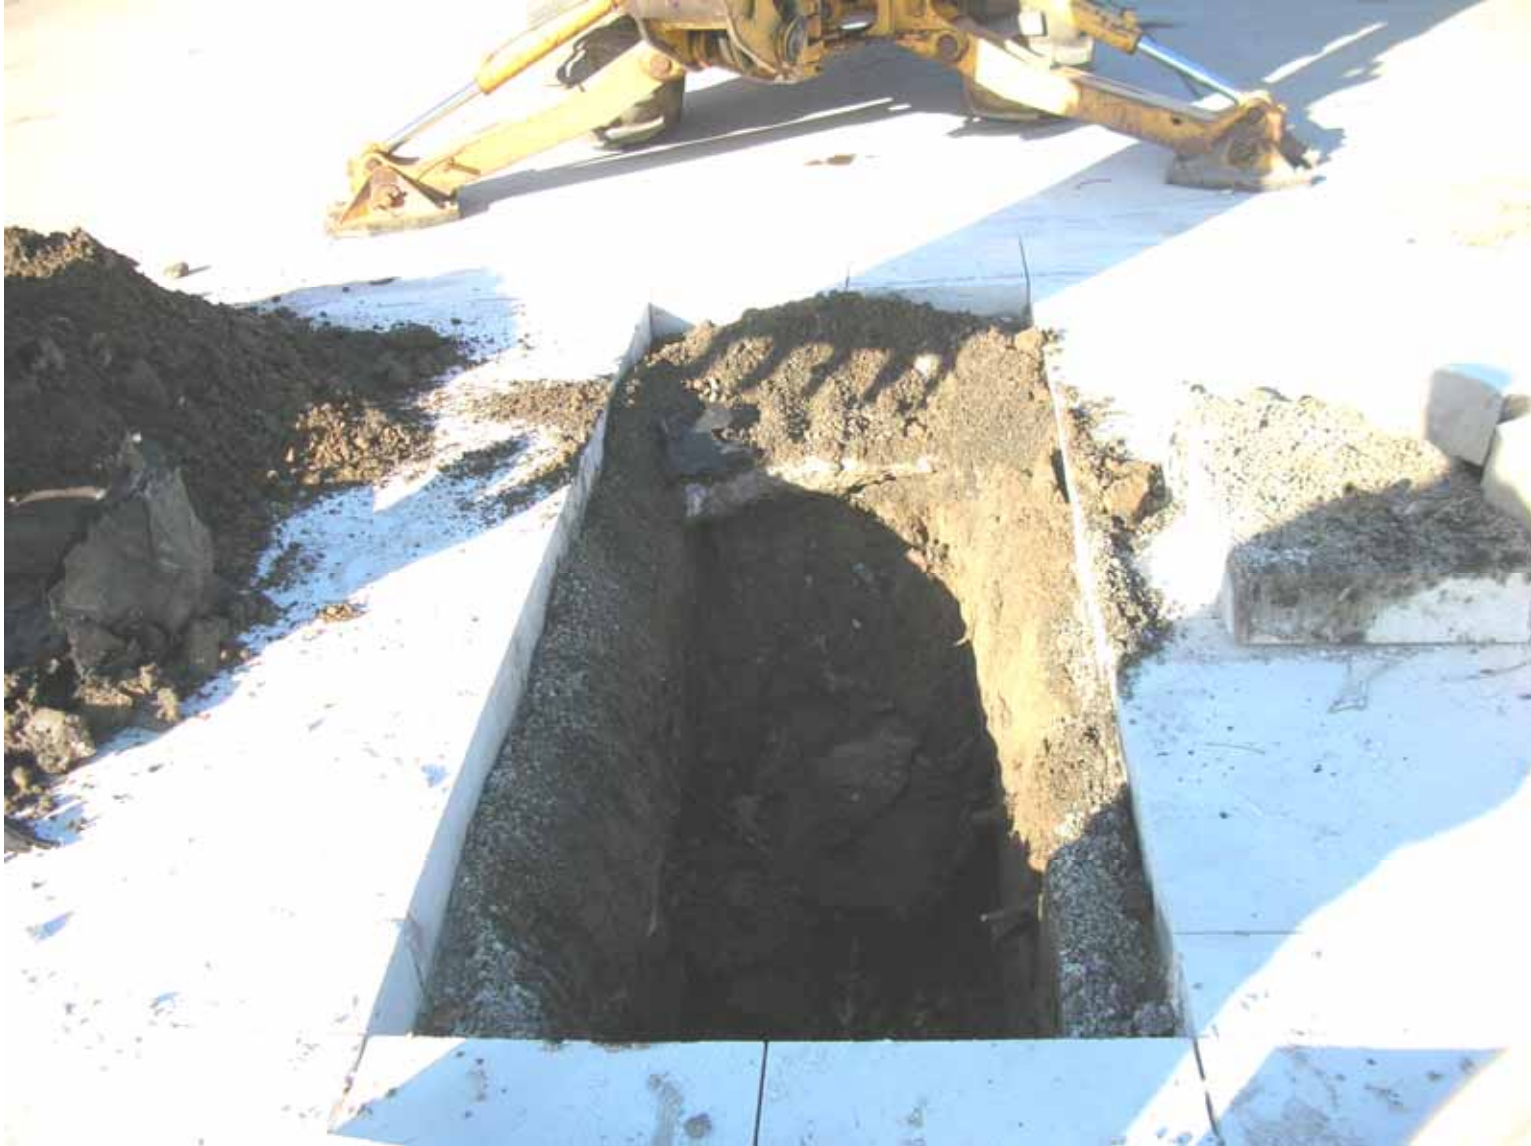
Test Pit 3 was located on the southeastern corner of the warehouse. This test pit also contained mostly silty material with no debris observed.

Test Pit TP-3

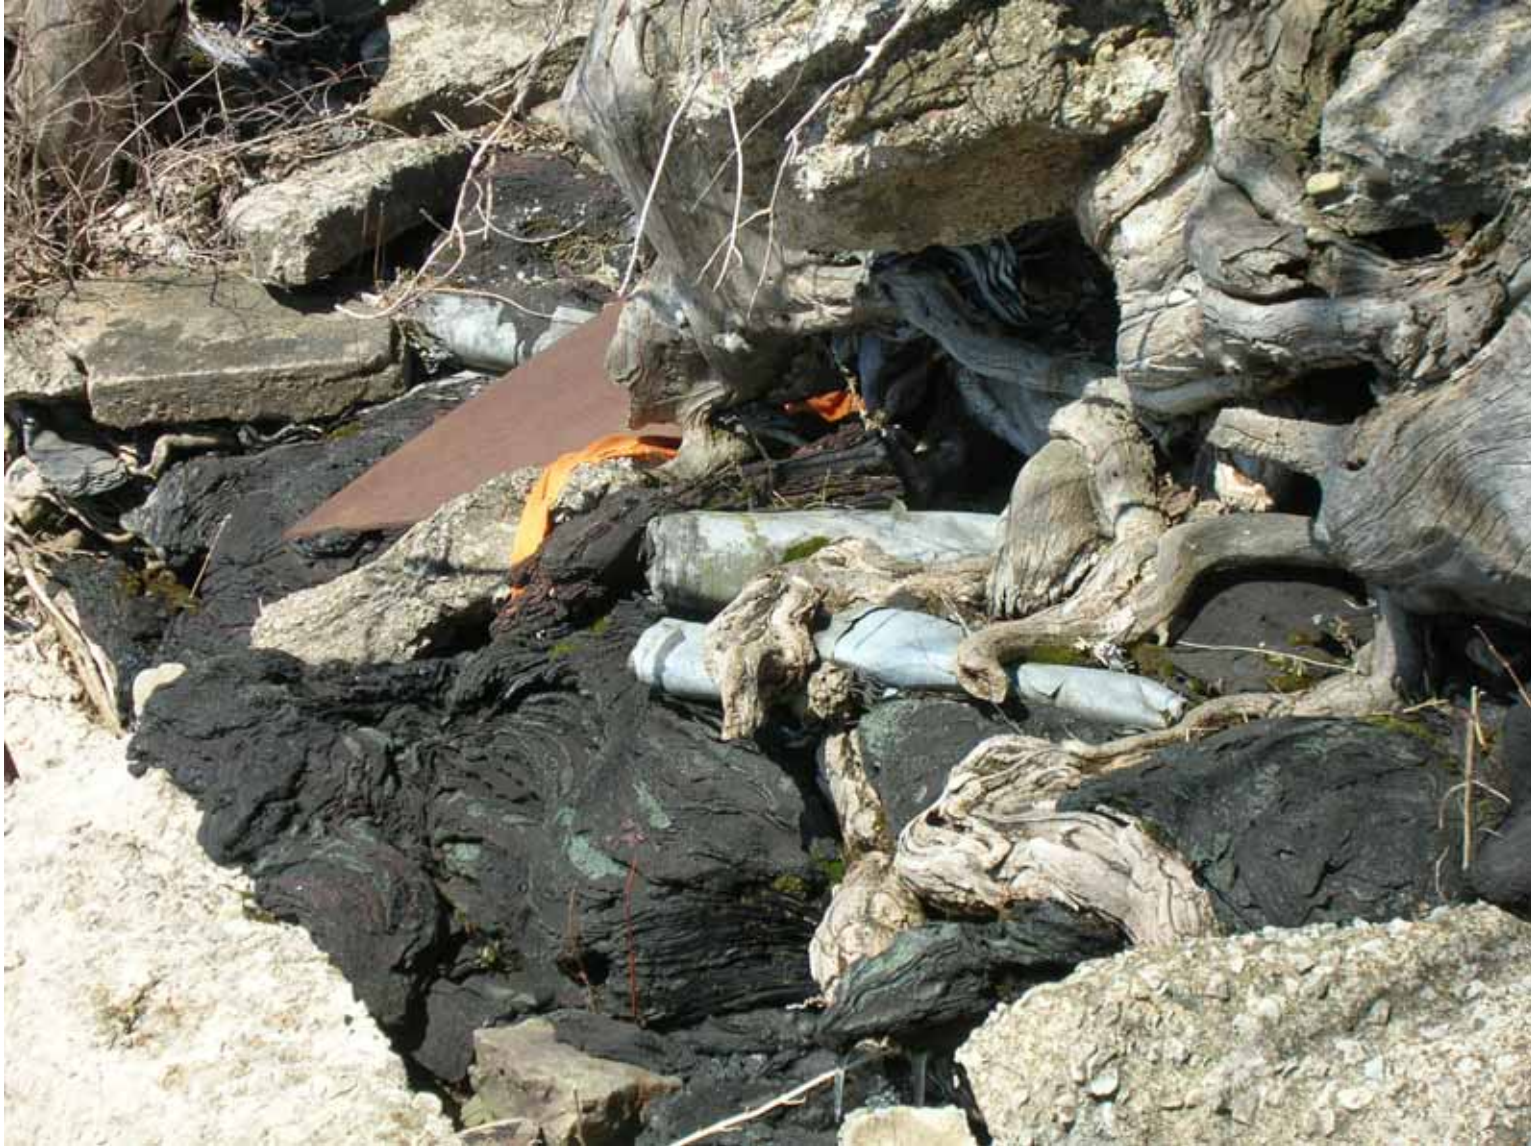
During the investigation, tar was noted expressing from the bank along the north and west shorelines on Presque Isle Bay. A photograph of this material on the western shoreline is provided in Appendix C. A sample of the tar was collected by chipping pieces off and placing them into a glass sample jar. The sample, numbered EMBANKMENT was submitted to TestAmerica in Pittsburgh, PA for VOCs, SVOCs PCBs and metals.

One bulk asbestos sample was collected from a roll of roofing material found protruding from the fill on the west bank of the Site on Presque Isle Bay. This material consisted of a flat roll of black paper containing white, fibrous materials in the matrix. Several of these rolls were noted at this location. These materials appeared to have been present in the fill and were encased with mature Cottonwood tree roots. Photographs of this material are included in Appendix C.

Western Bank of Site on Presque Isle Bay – Tar Expression and Asbestos Paper Rolls

During the sediment sampling, a number of areas were noted along the shoreline where tar was expressing from the fill into the bay. A sample of the tar was collected and found to contain PAHs. It will be necessary to mitigate the tar seeps to the bay in order to complete the remediation of the Site.

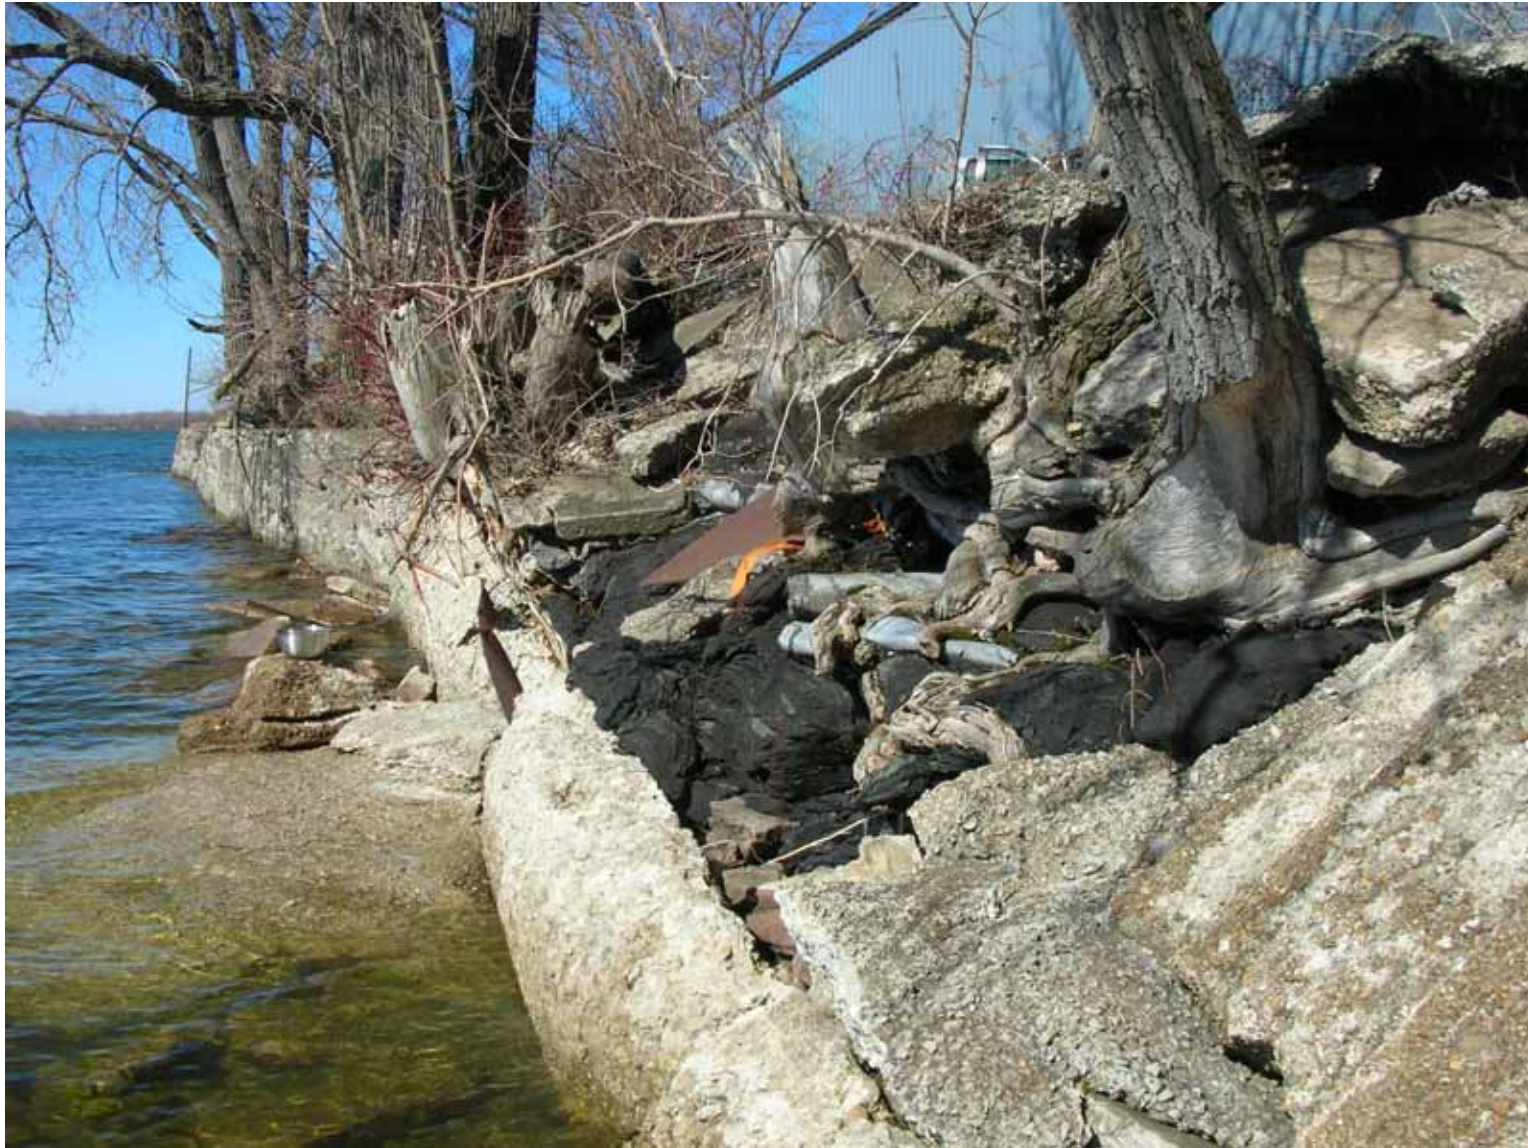
One asbestos sample (ASB-OUT-1) was collected from a roll of tar paper found protruding from the fill on the western bank of the property. This material was identified during the sediment sampling effort. The sample was collected by cutting several pieces of the material off and placing them in a sealable plastic bag. The sample was sent to R. J. Lee for analysis by polarized light microscopy (PLM). The location of the sample ASB-OUT-1 is shown on Figure 6.

Western Bank of Site on Presque Isle Bay – Tar Expression and Asbestos Paper Rolls
