**PHASE I ENVIRONMENTAL  
SITE ASSESSMENT**

**GAF BUILDING MATERIALS CORPORATION, INC. SITE  
218 West Bayfront Parkway, Erie, PA 16507**

**Erie County Convention Center Authority**

**November 6, 2008**

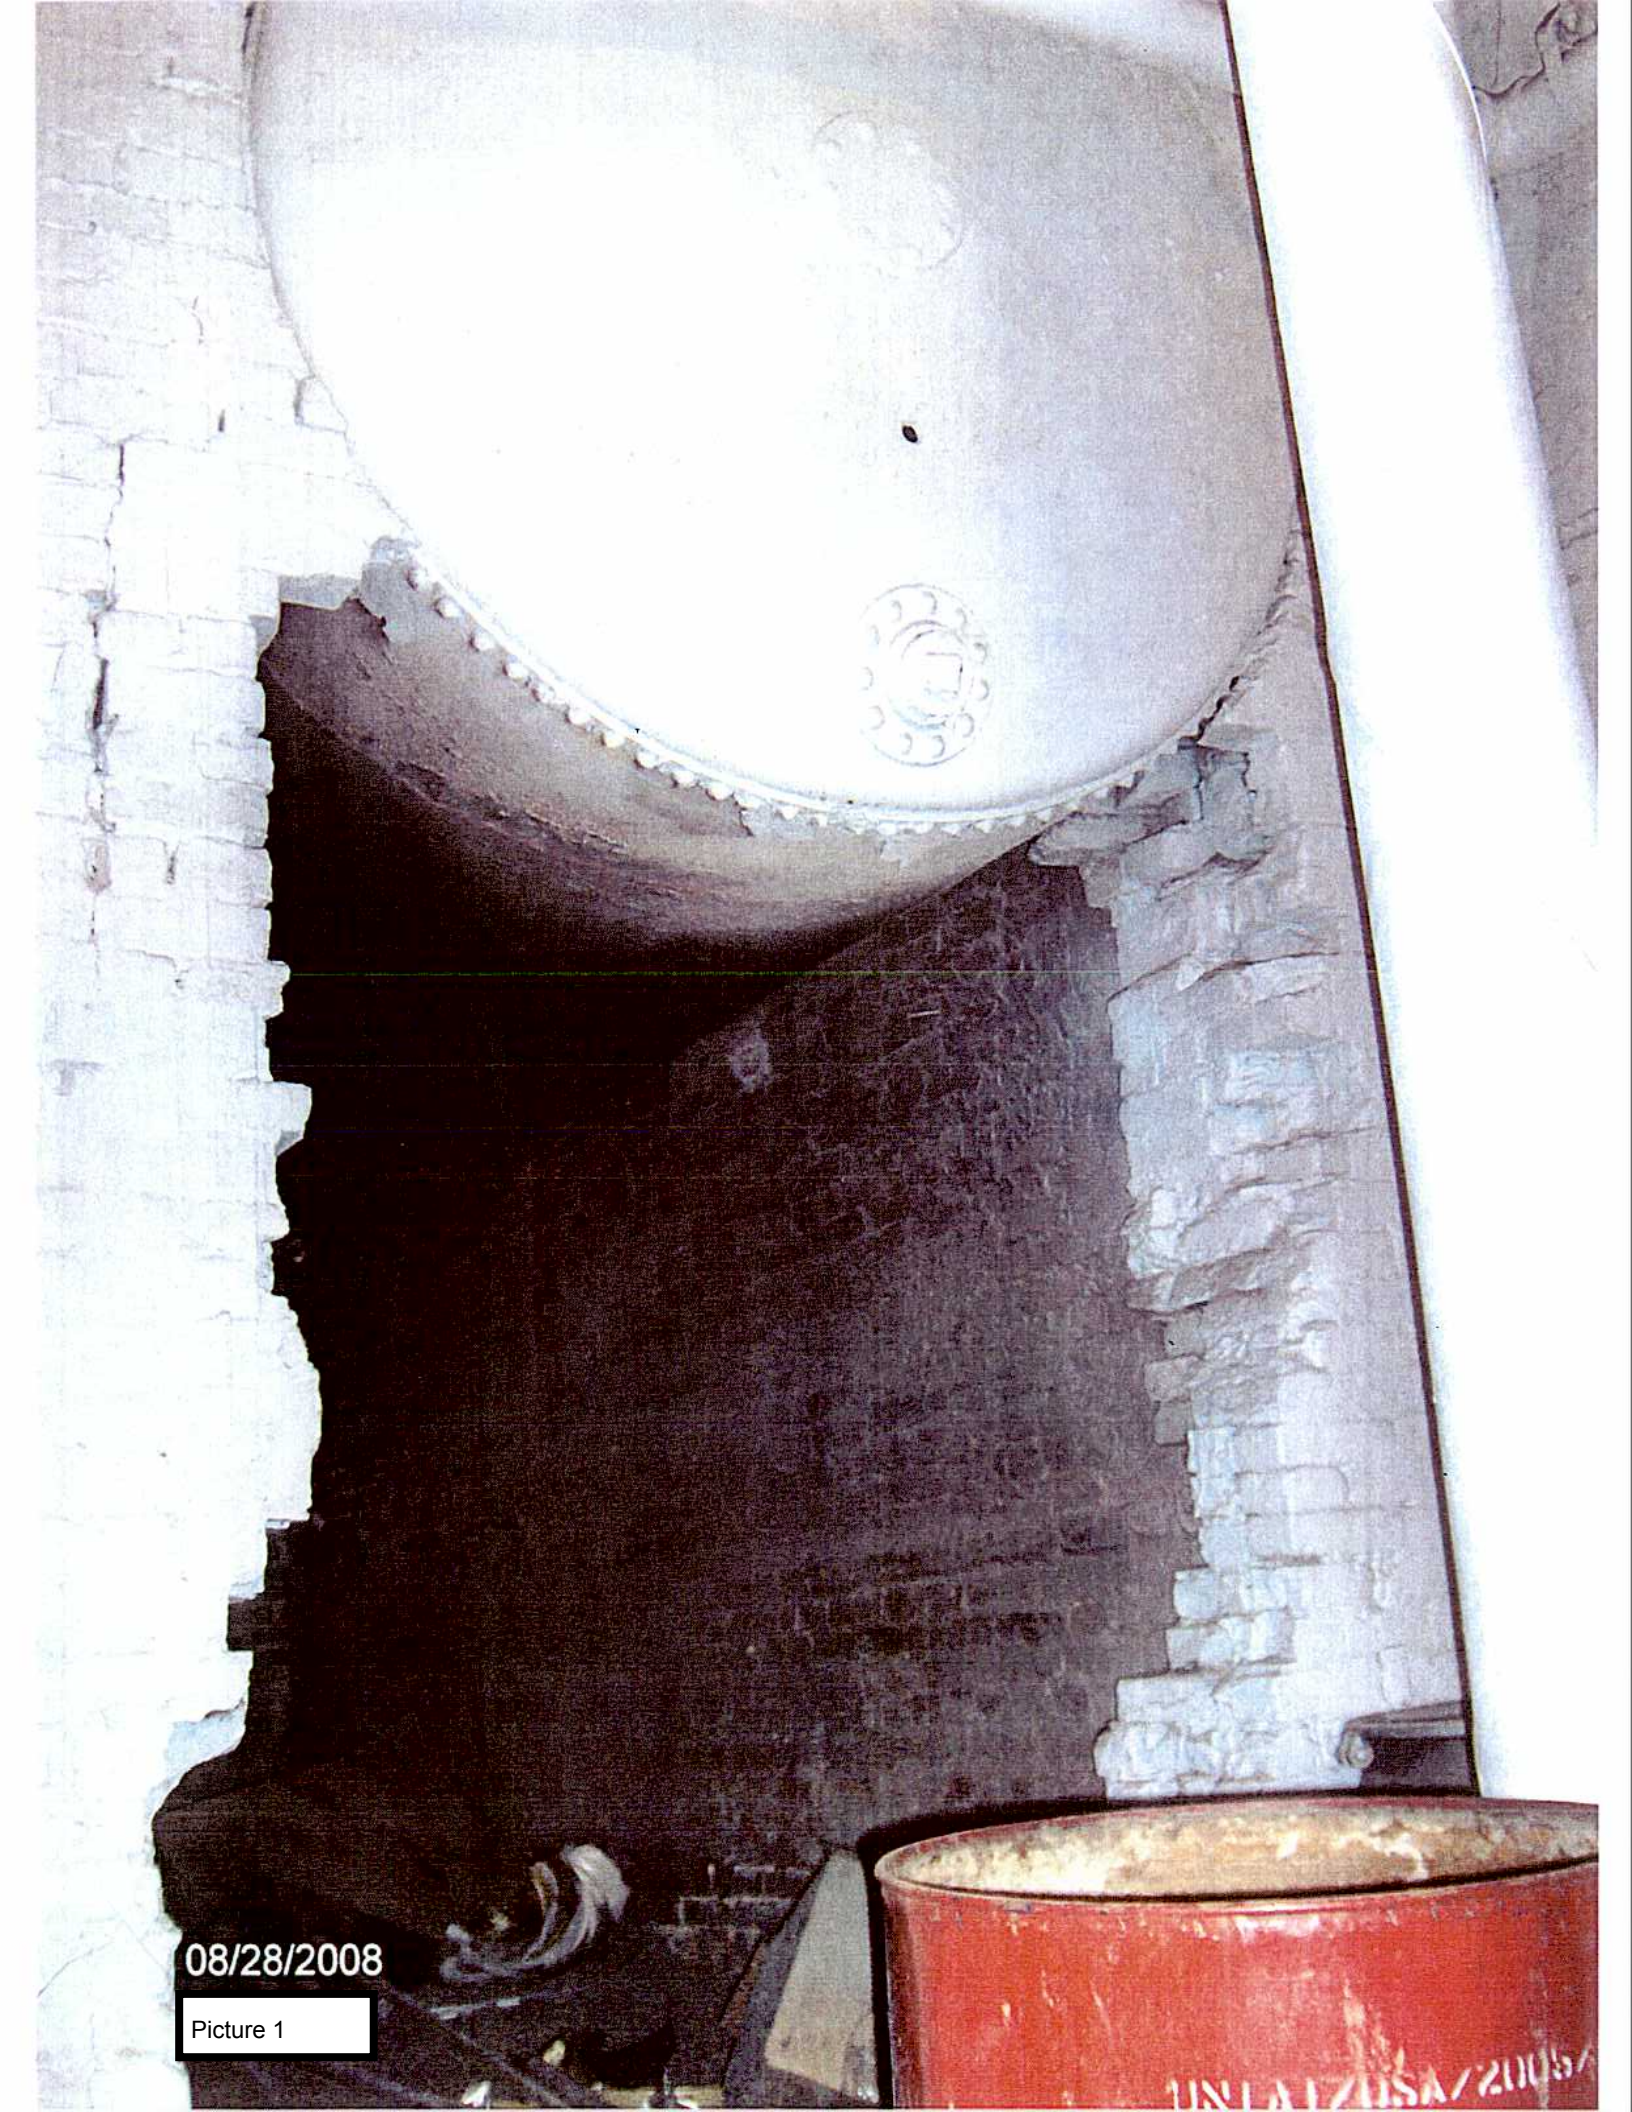
Picture 1

- Photo #1 End of northernmost old asphalt tank in Bldg. 8. Historically, tanks were heated with fires below tank.
- Photo #2 View of hallway of old tanks looking south in Bldg 8.

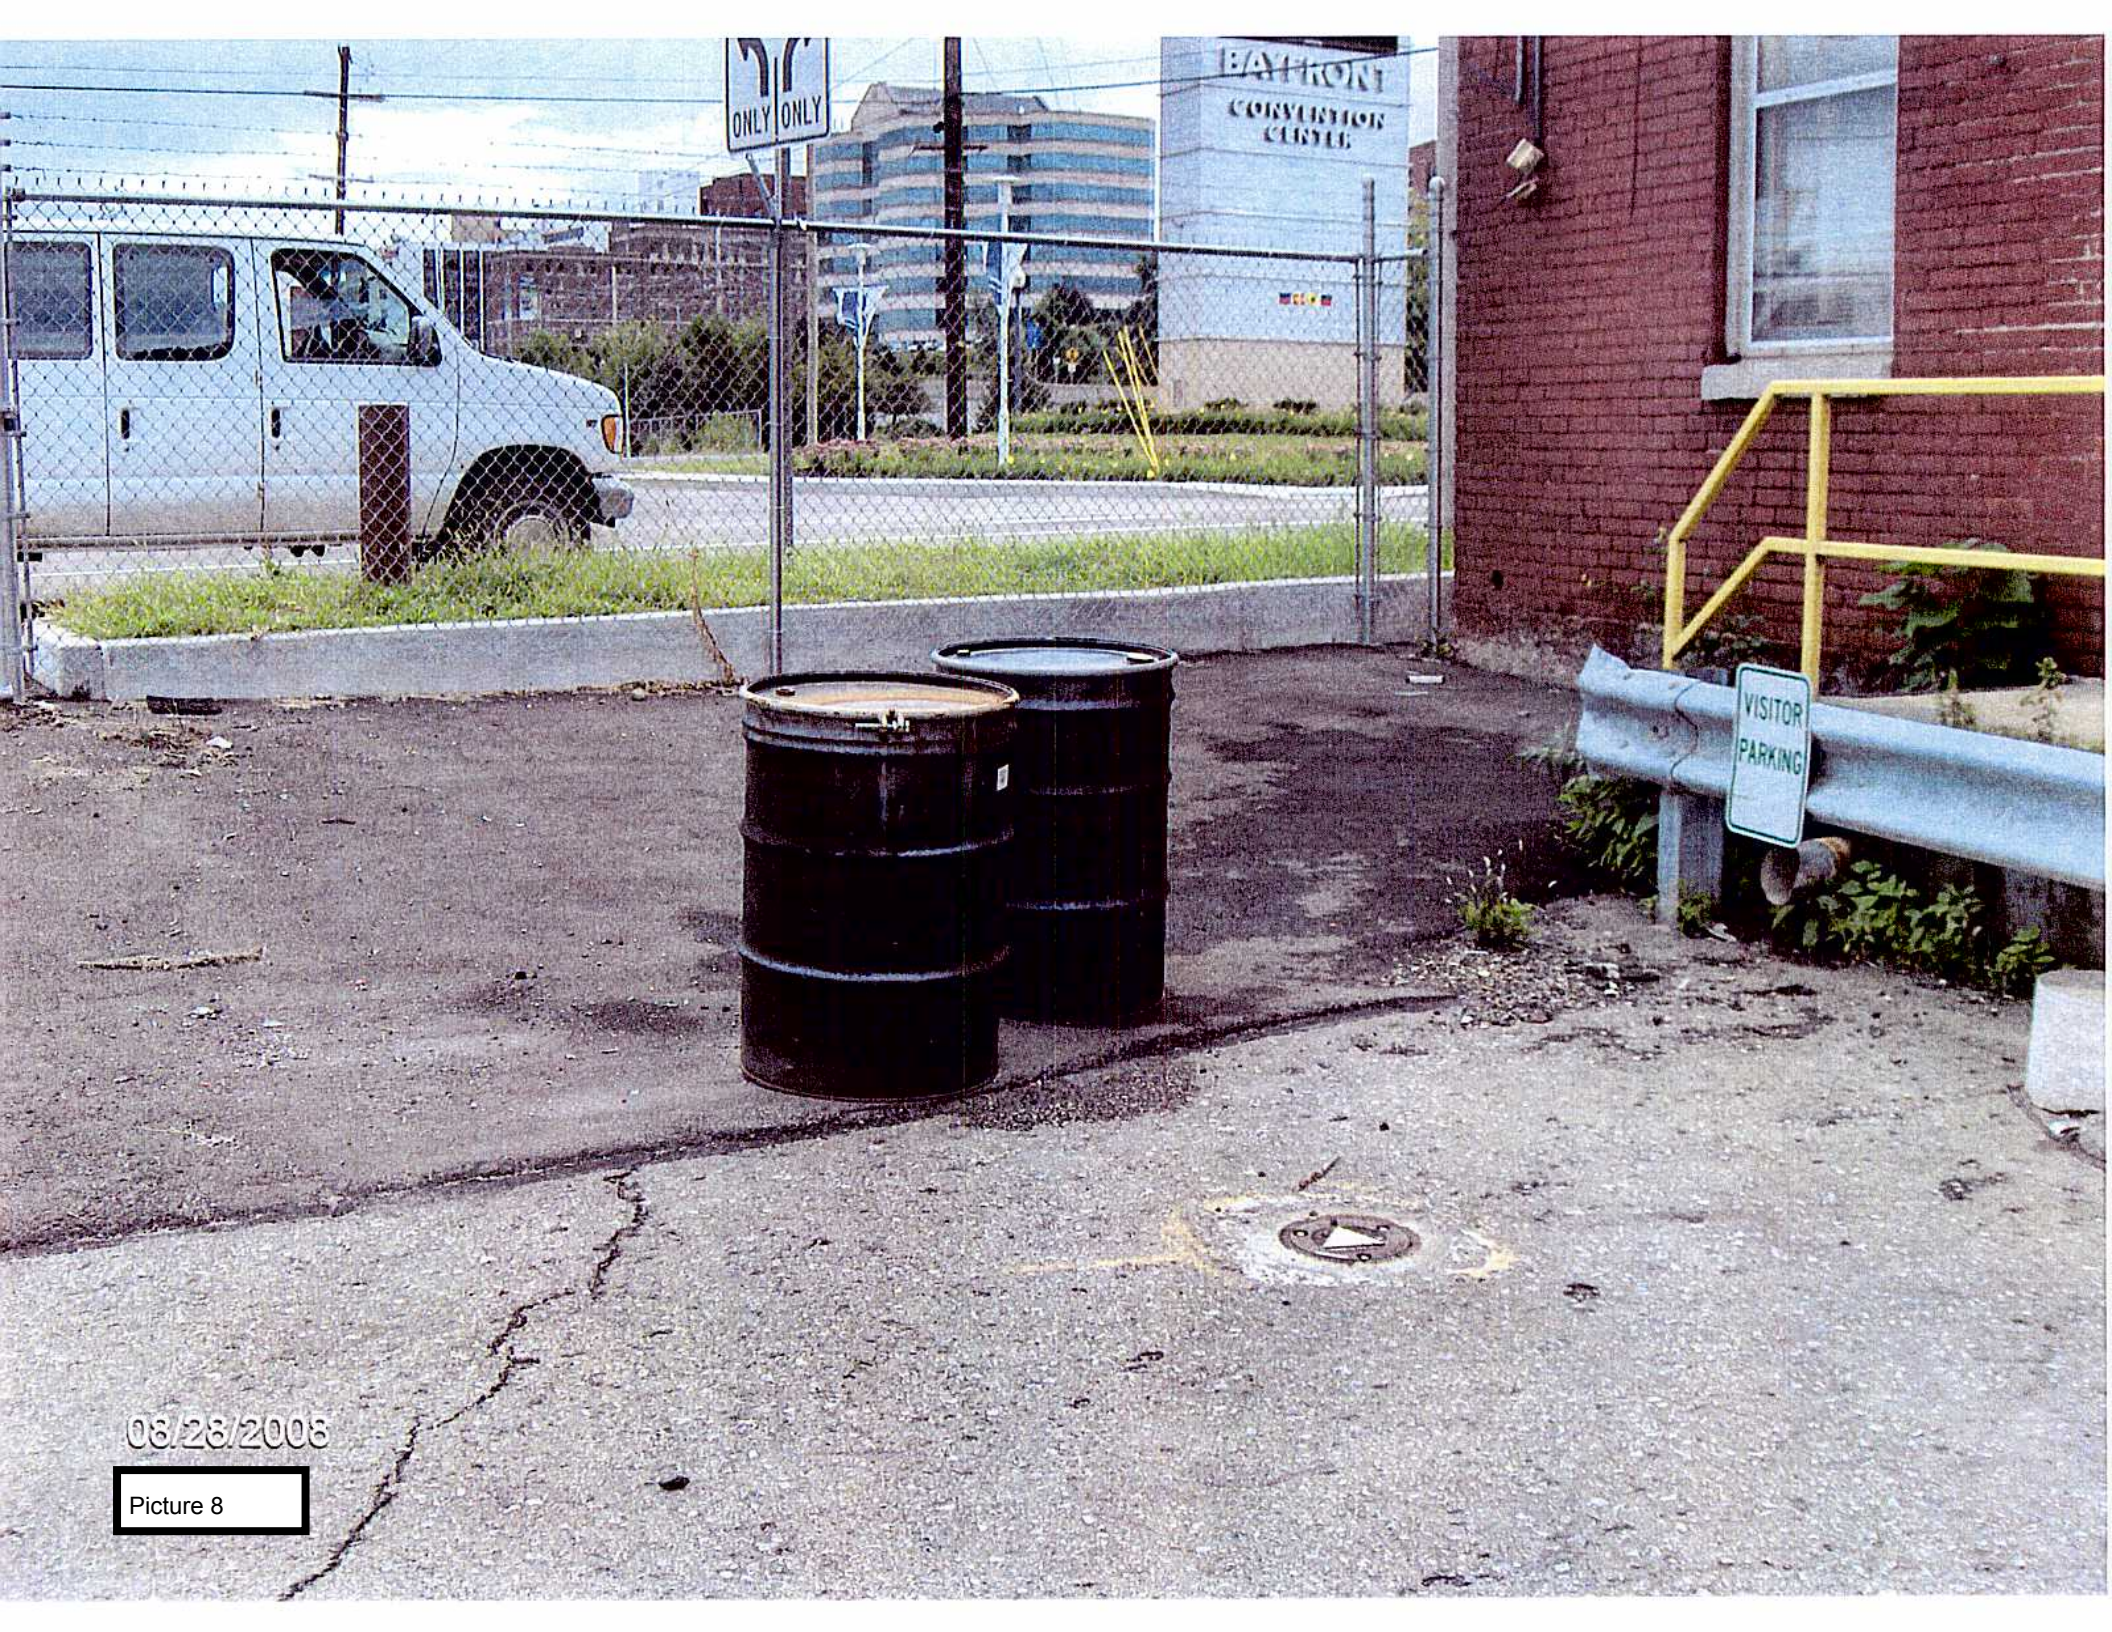
Picture 8

- Photo #7 View of old oil water separator north of front loading docks near Tank 4.
- Photo #8 View looking east of MW near northeast corner of office building. Note drums of purge water onsite.

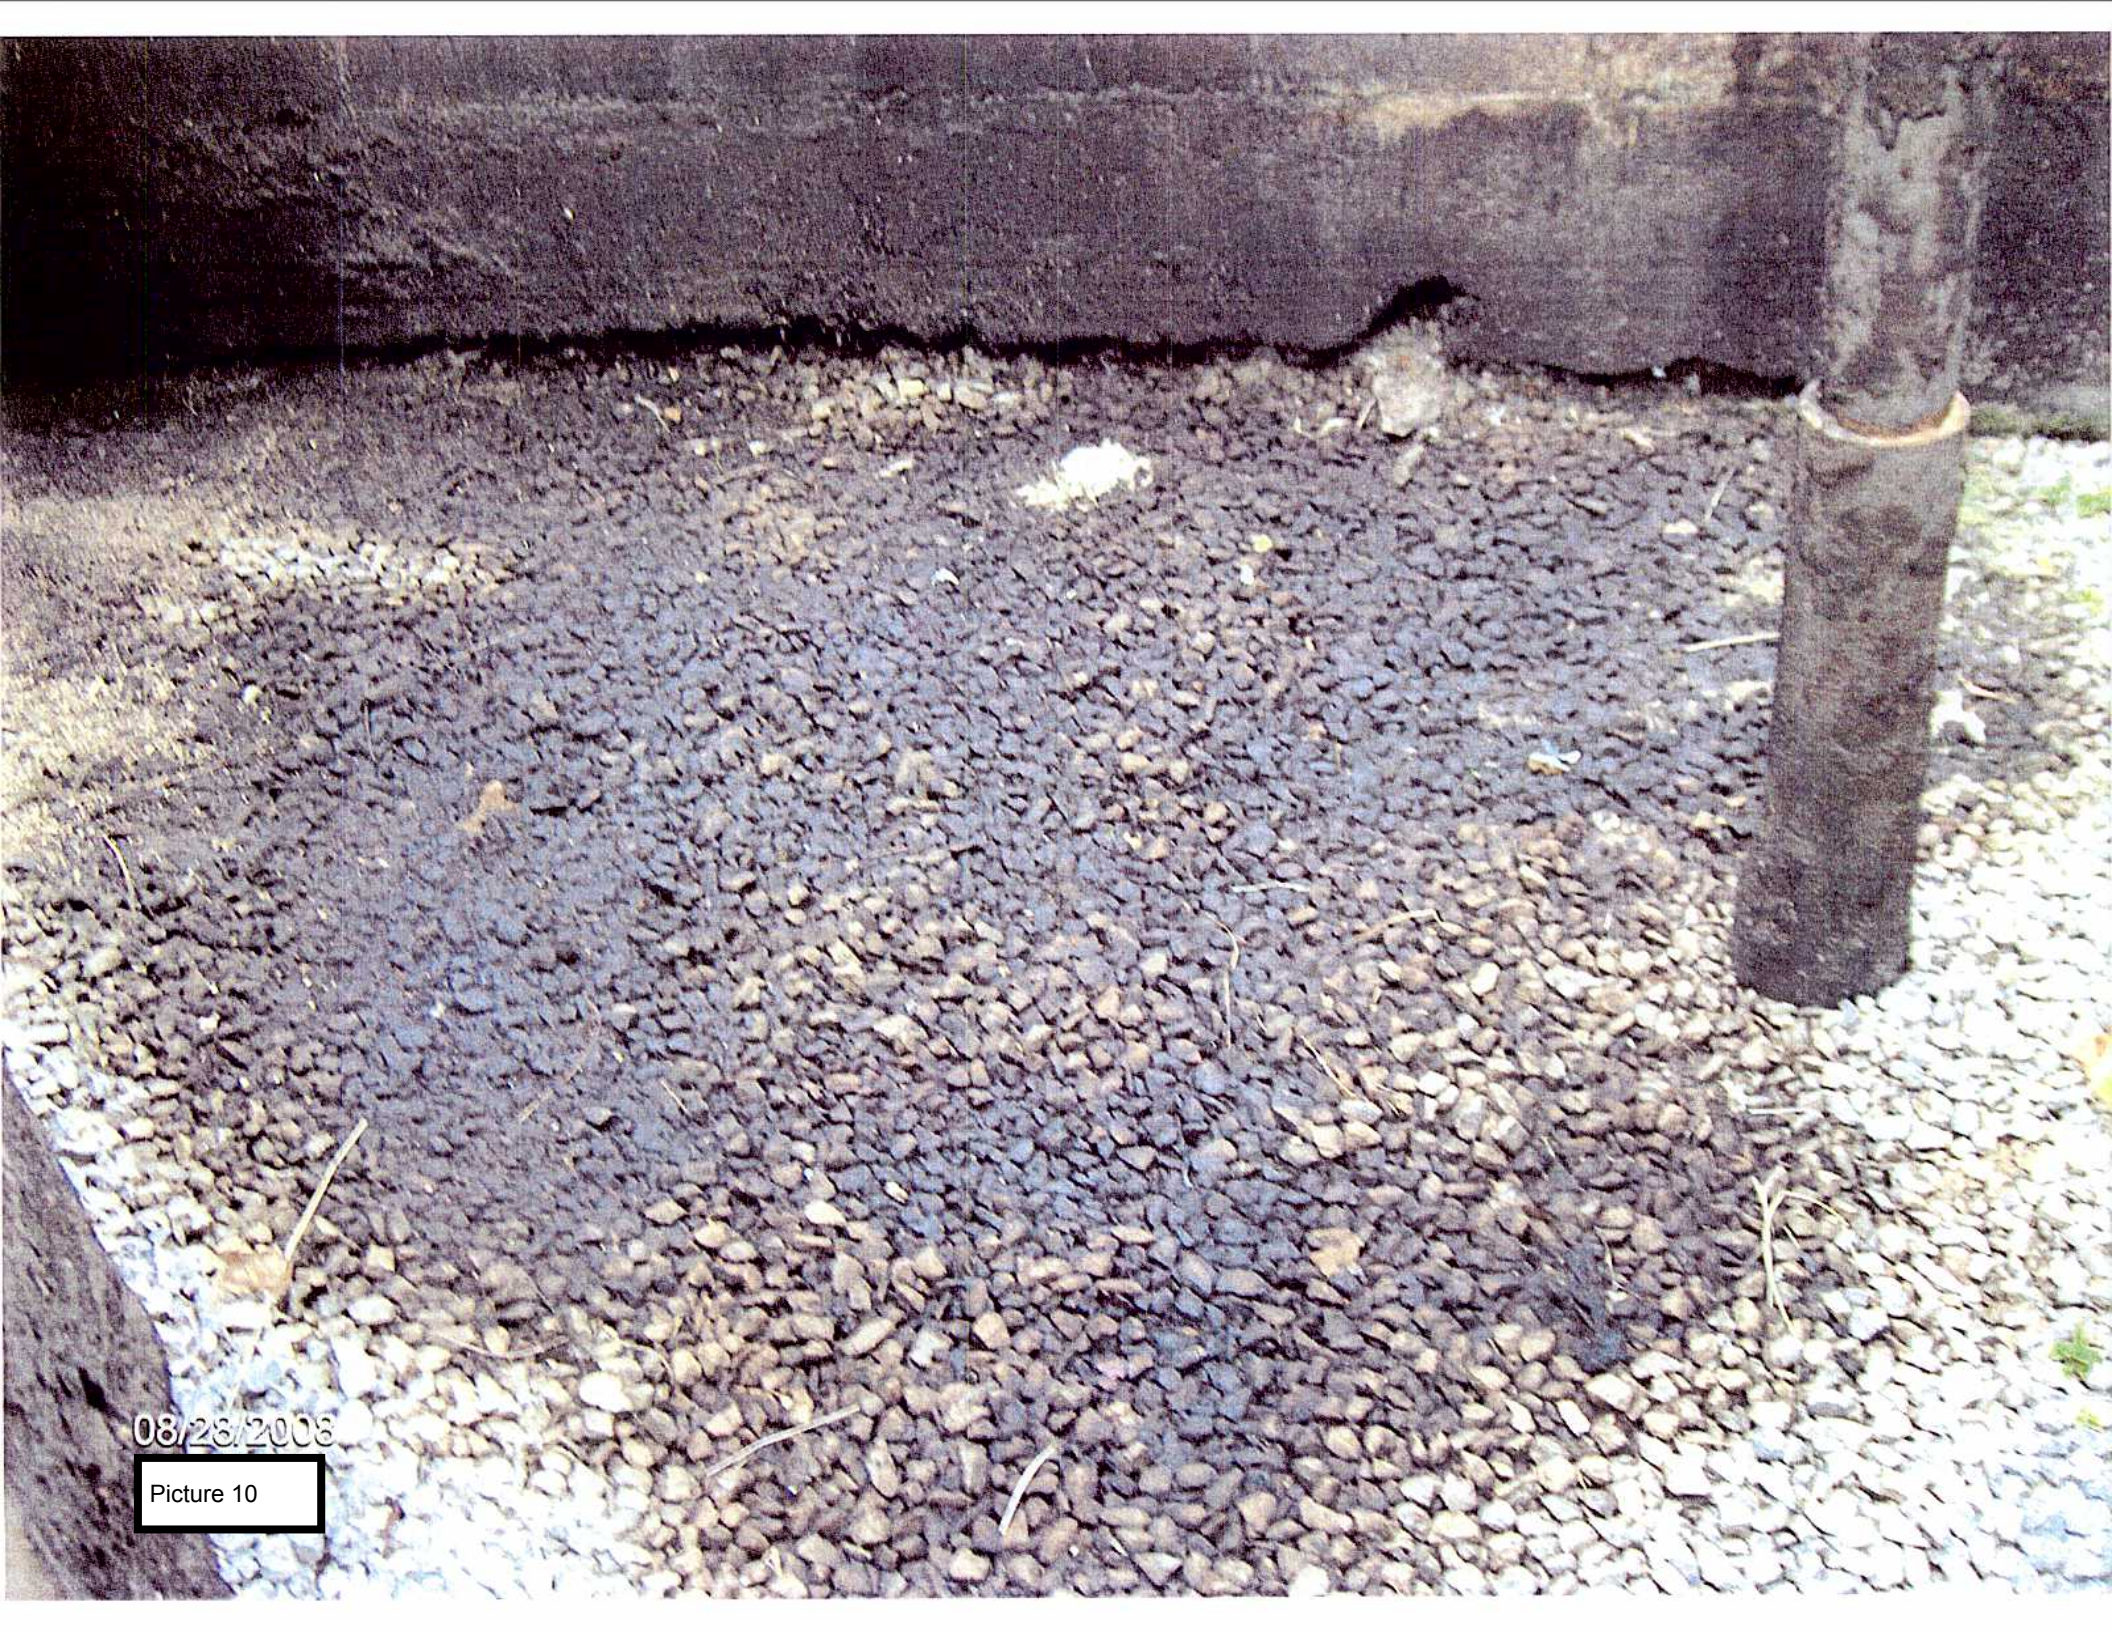
Picture 10

- Photo #9 View of oil water separators and heated product tanks looking north from front loading docks.
- Photo #10 View of fairly recently stained soils near tank 4 or 5?

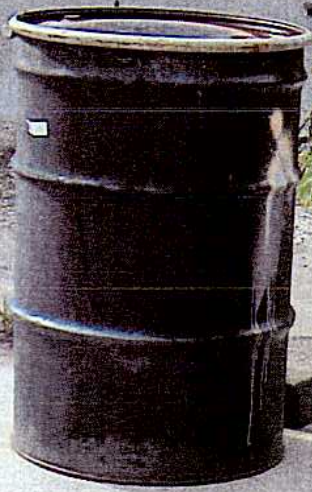
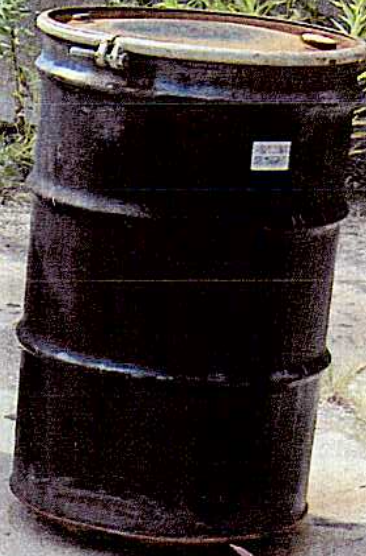
Picture 15

- Photo #13 View of asphalt contaminated walls and ground in or near Bldg. 40.
- Photo #14 View of facility flare facing south/southwest.
- Photo #15 View looking southwest of MW north of boiler house. Note drums of purge water onsite.

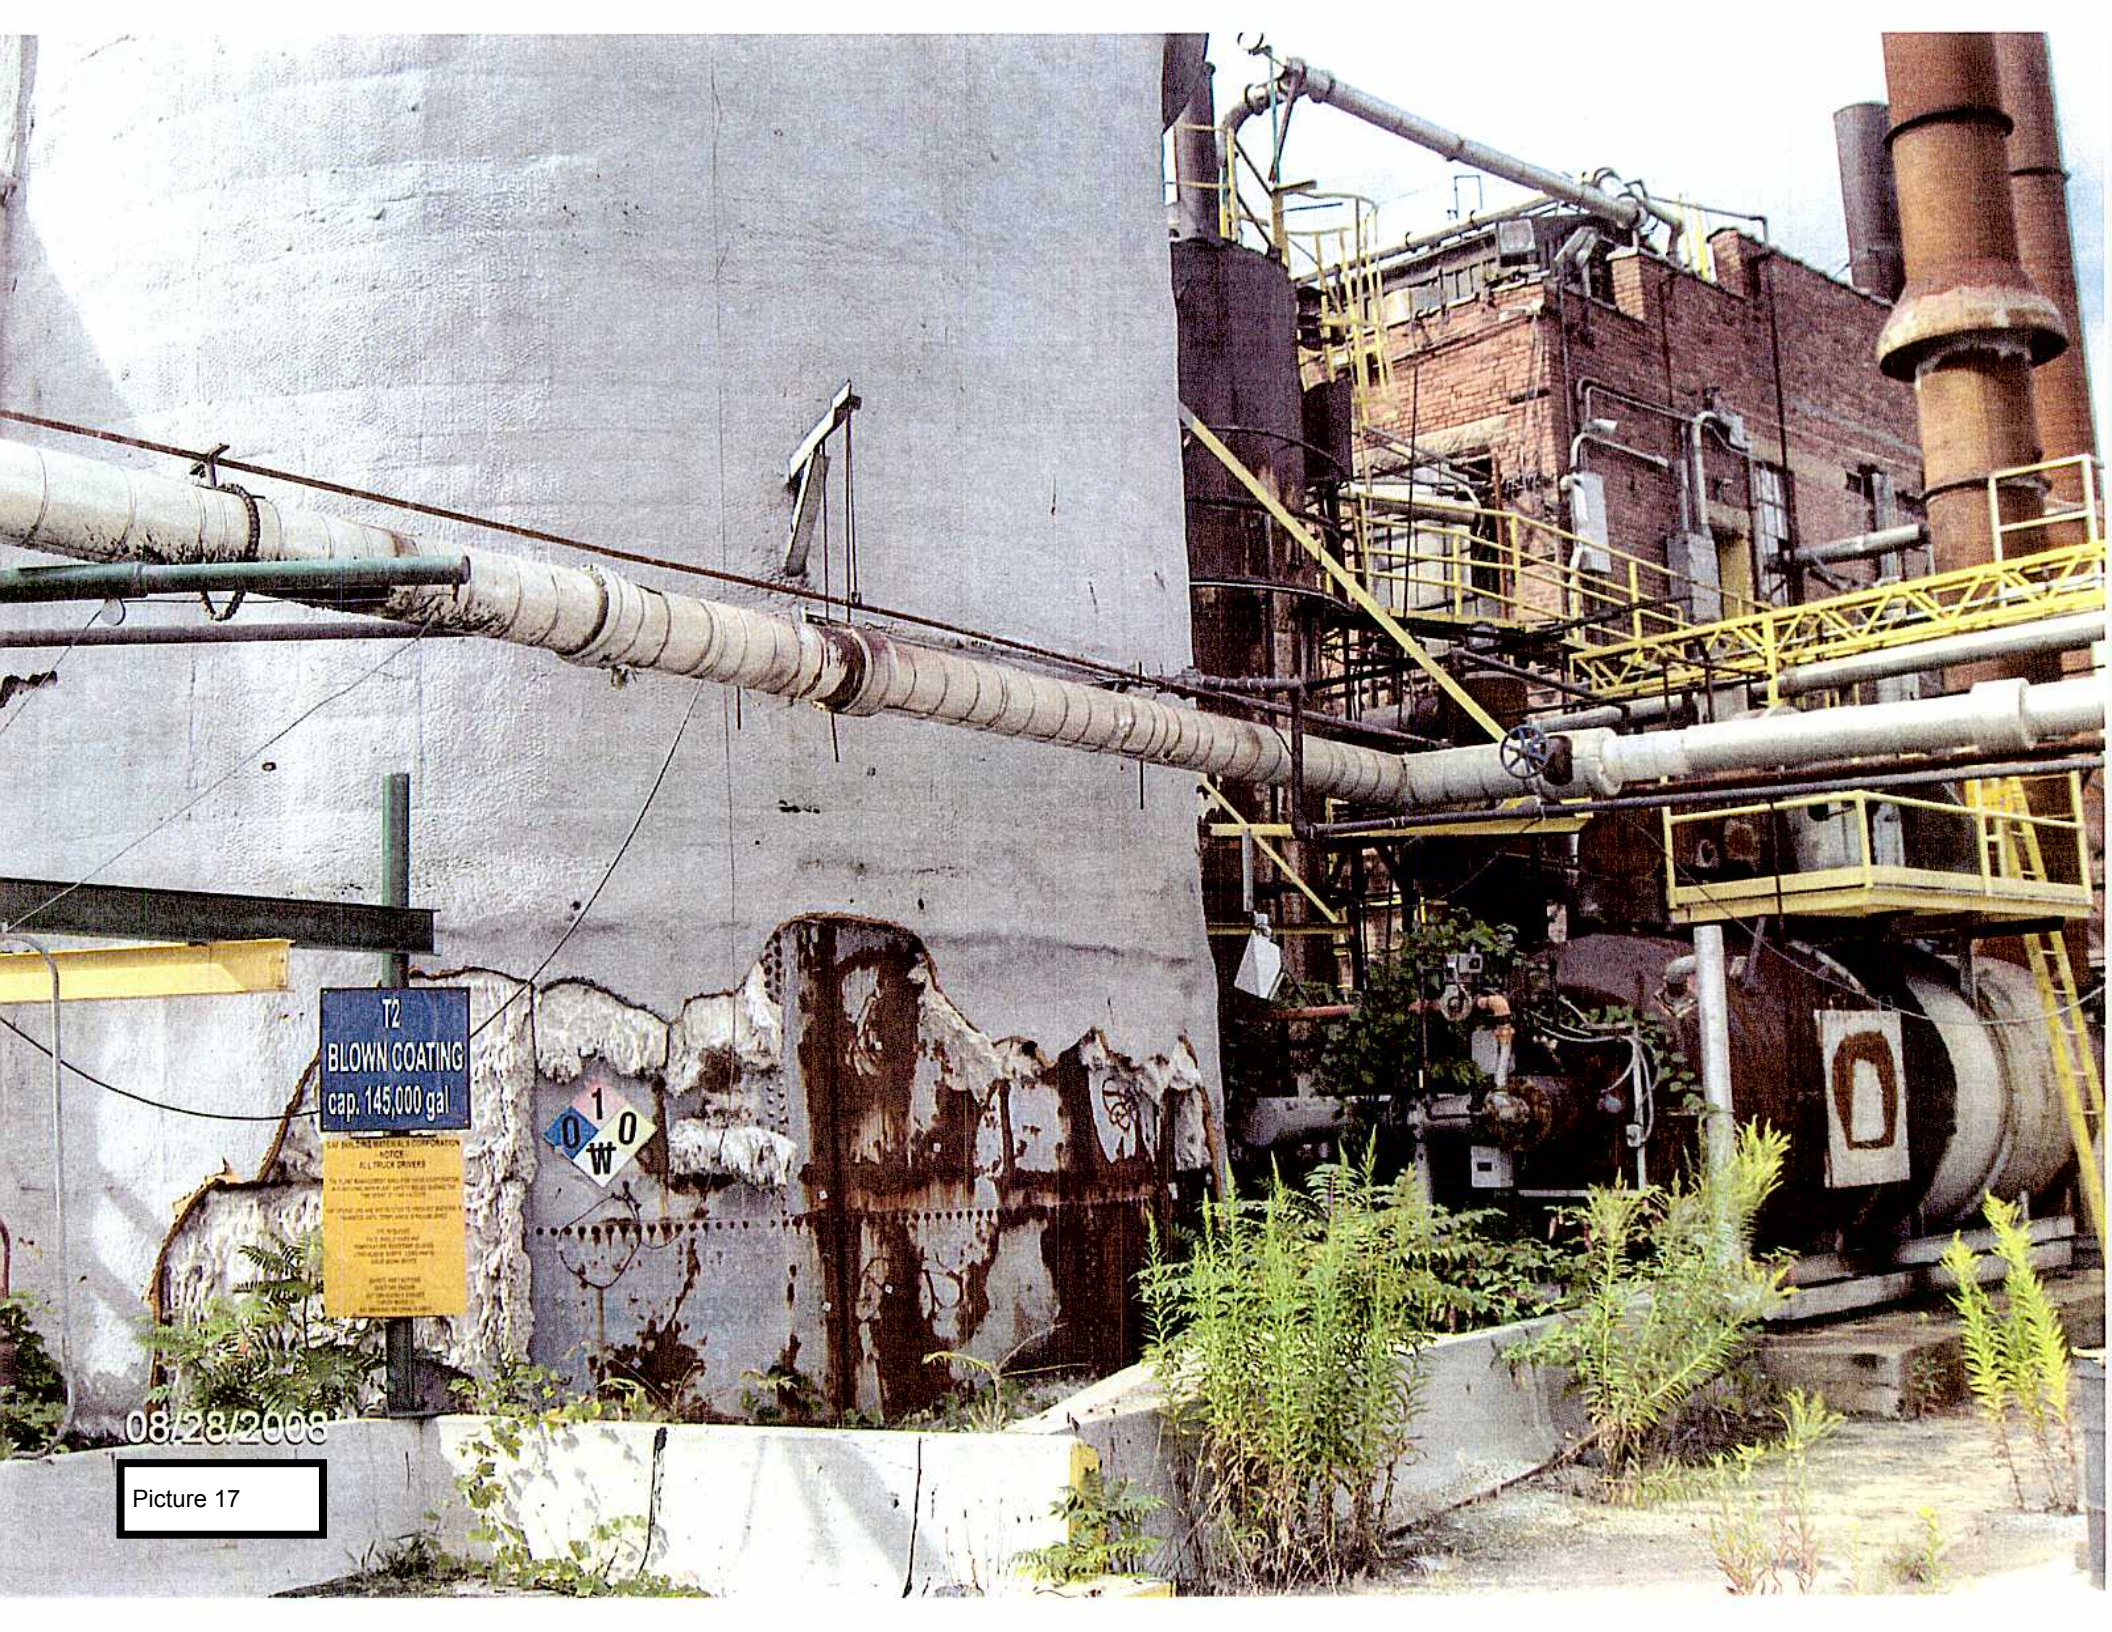
Picture 17

T2  
BLOWN COATING  
cap. 145,000 gal

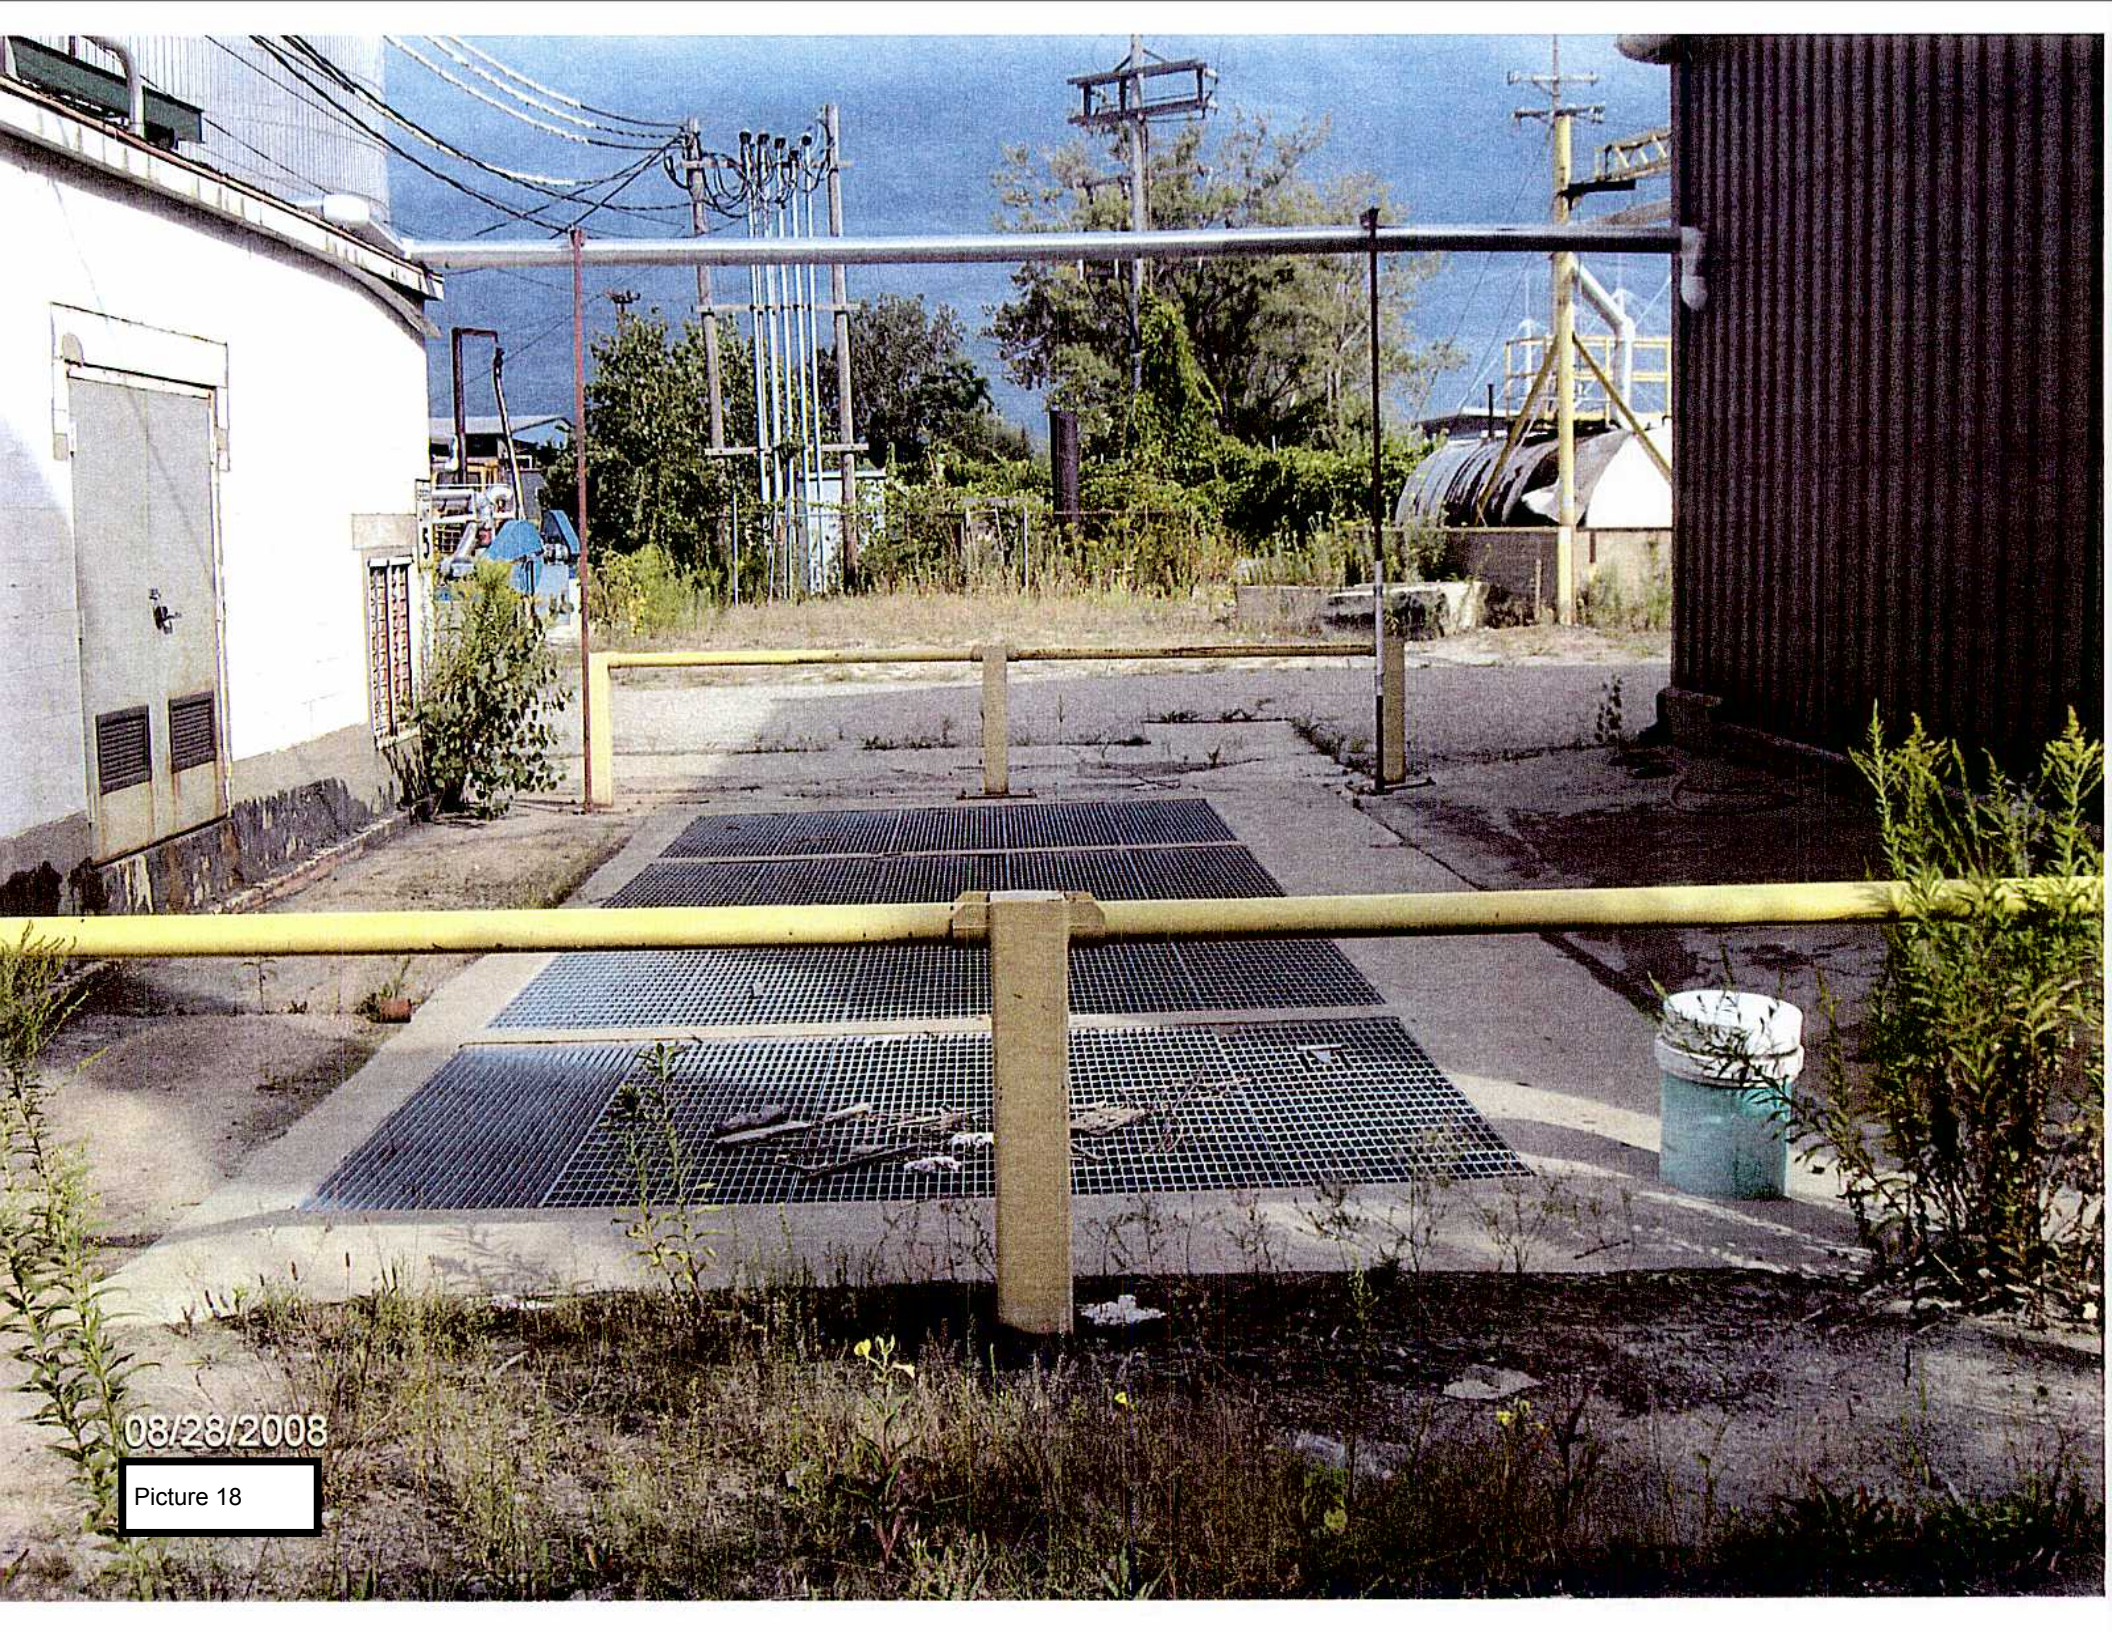
Picture 18

- Photo #16 View of former blown coating tanks east of flare.
- Photo #17 View of former blown coating tanks east of flare.
- Photo #18 View of new oil/water separator north of flare looking north.

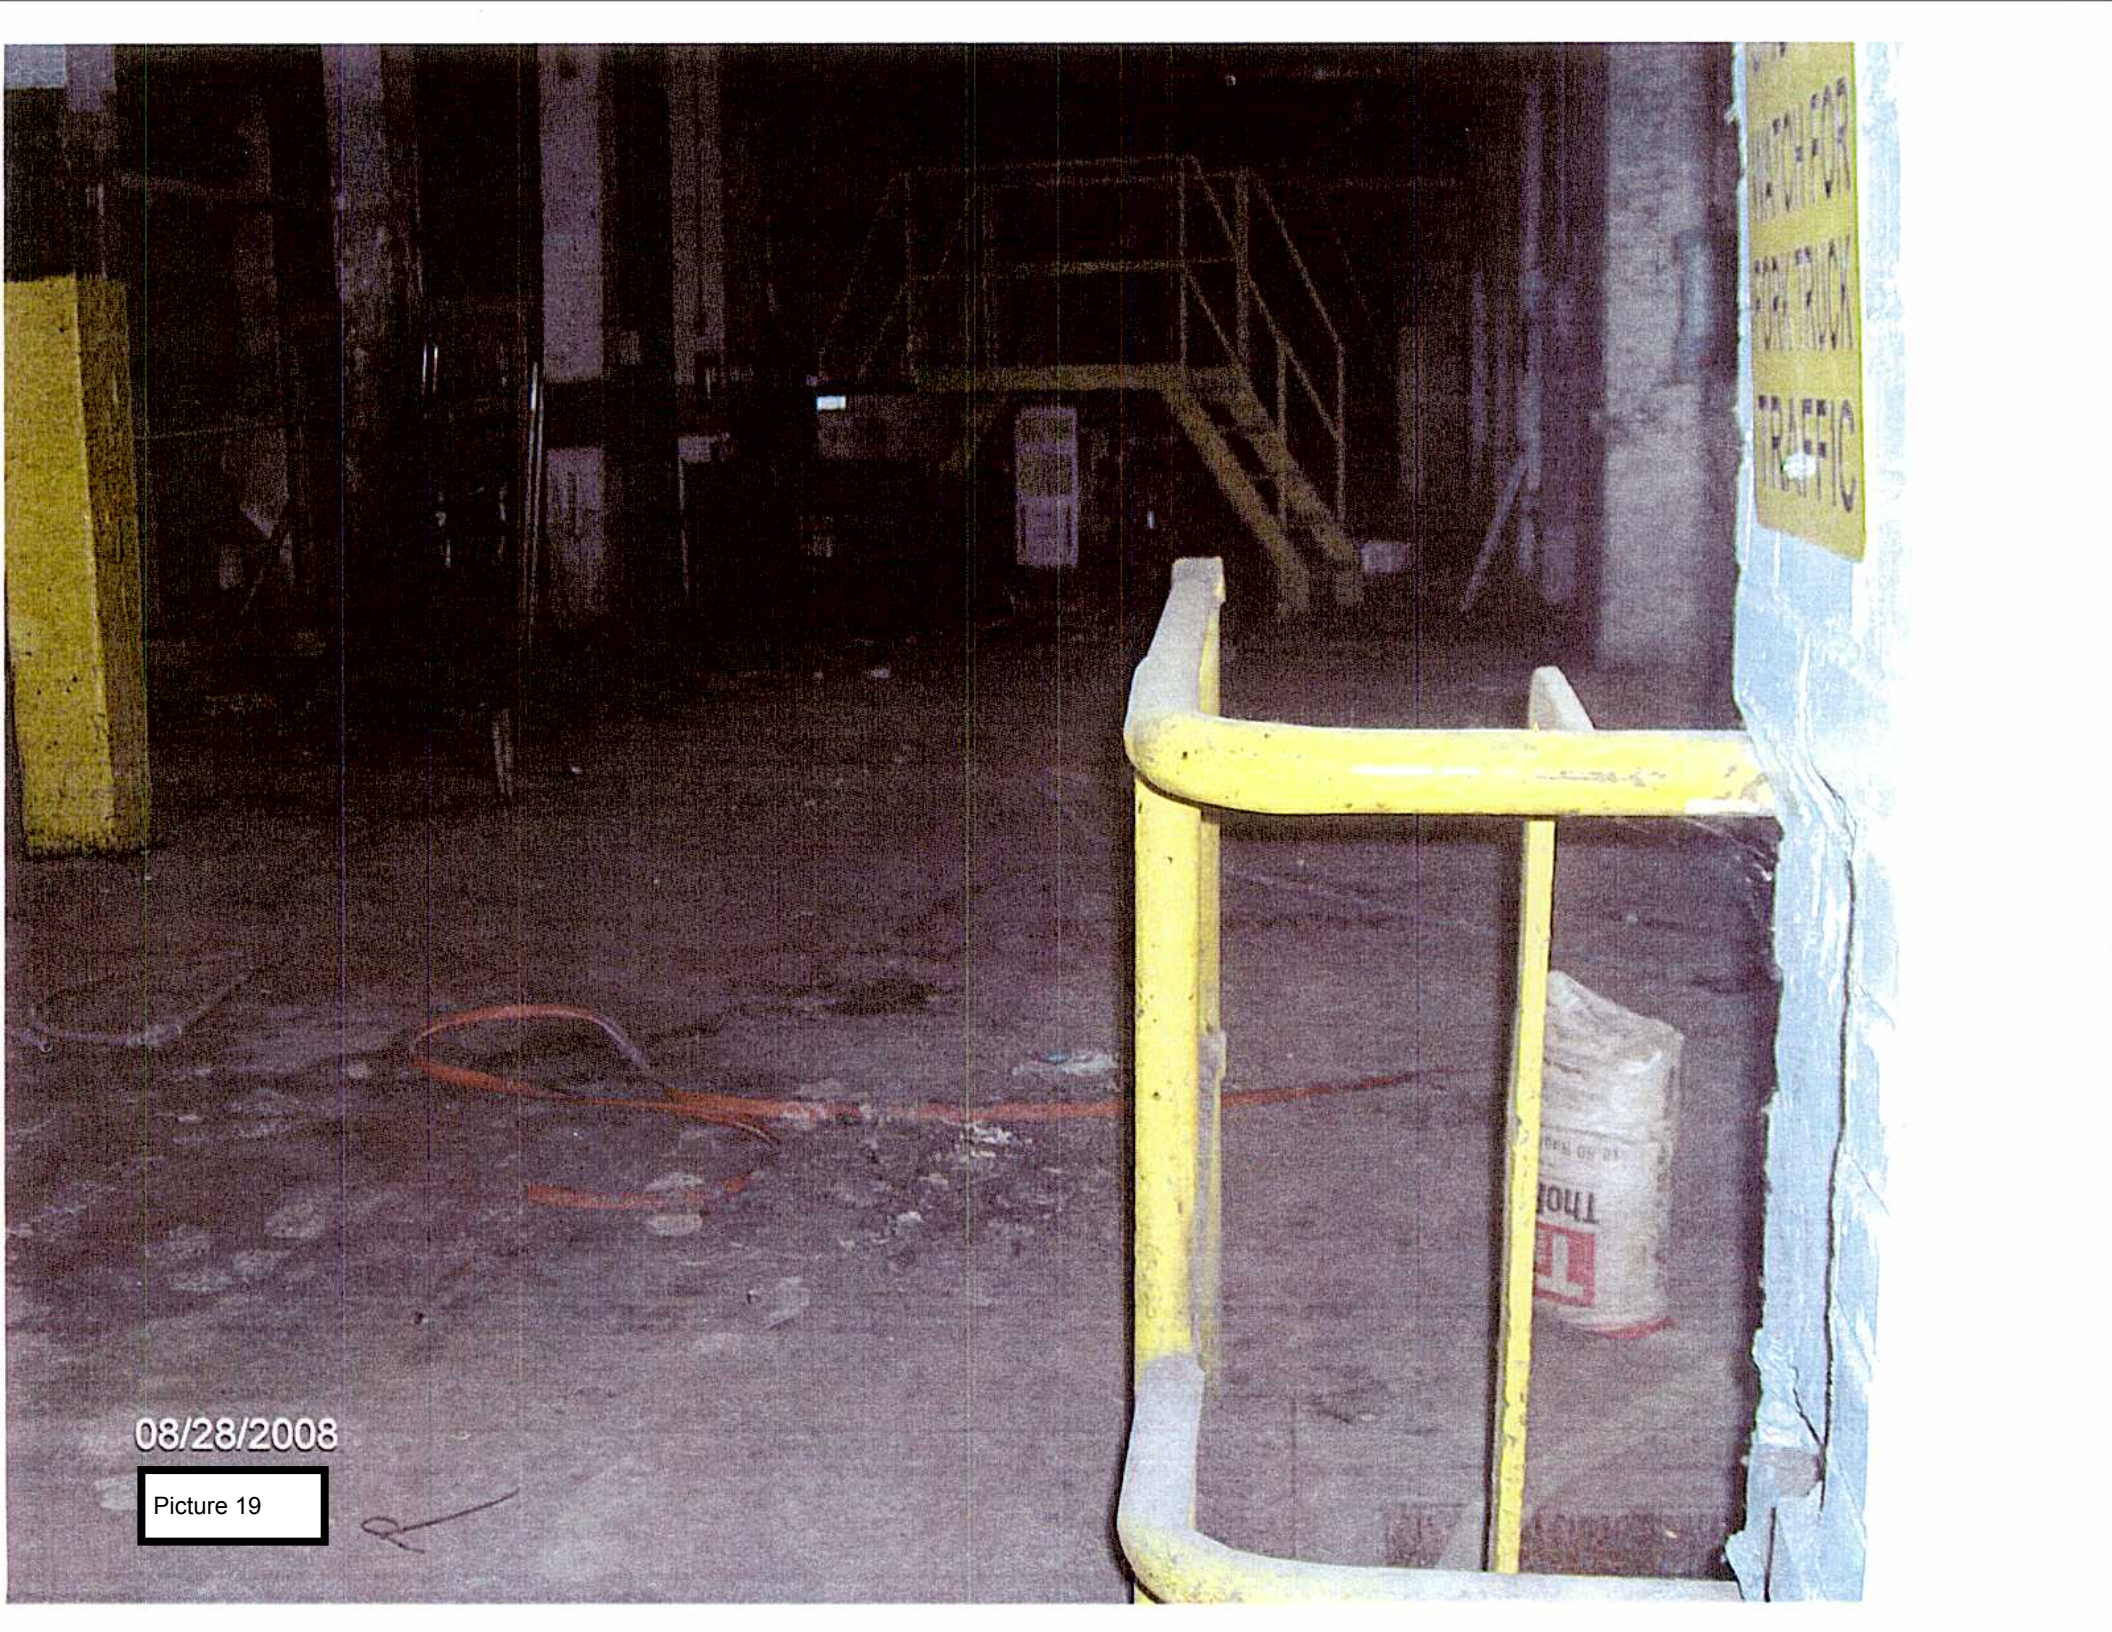
Picture 19

- Photo #19 Photo near rolled roofing line in area w/ basement.
- Photo #20 Photo of rolled roofing line.
- Photo #21 Photo of air pollution control device for rolled roofing line.
