**PHASE I ENVIRONMENTAL  
SITE ASSESSMENT**

**GAF BUILDING MATERIALS CORPORATION, INC. SITE  
218 West Bayfront Parkway, Erie, PA 16507**

**Erie County Convention Center Authority**

**November 6, 2008**

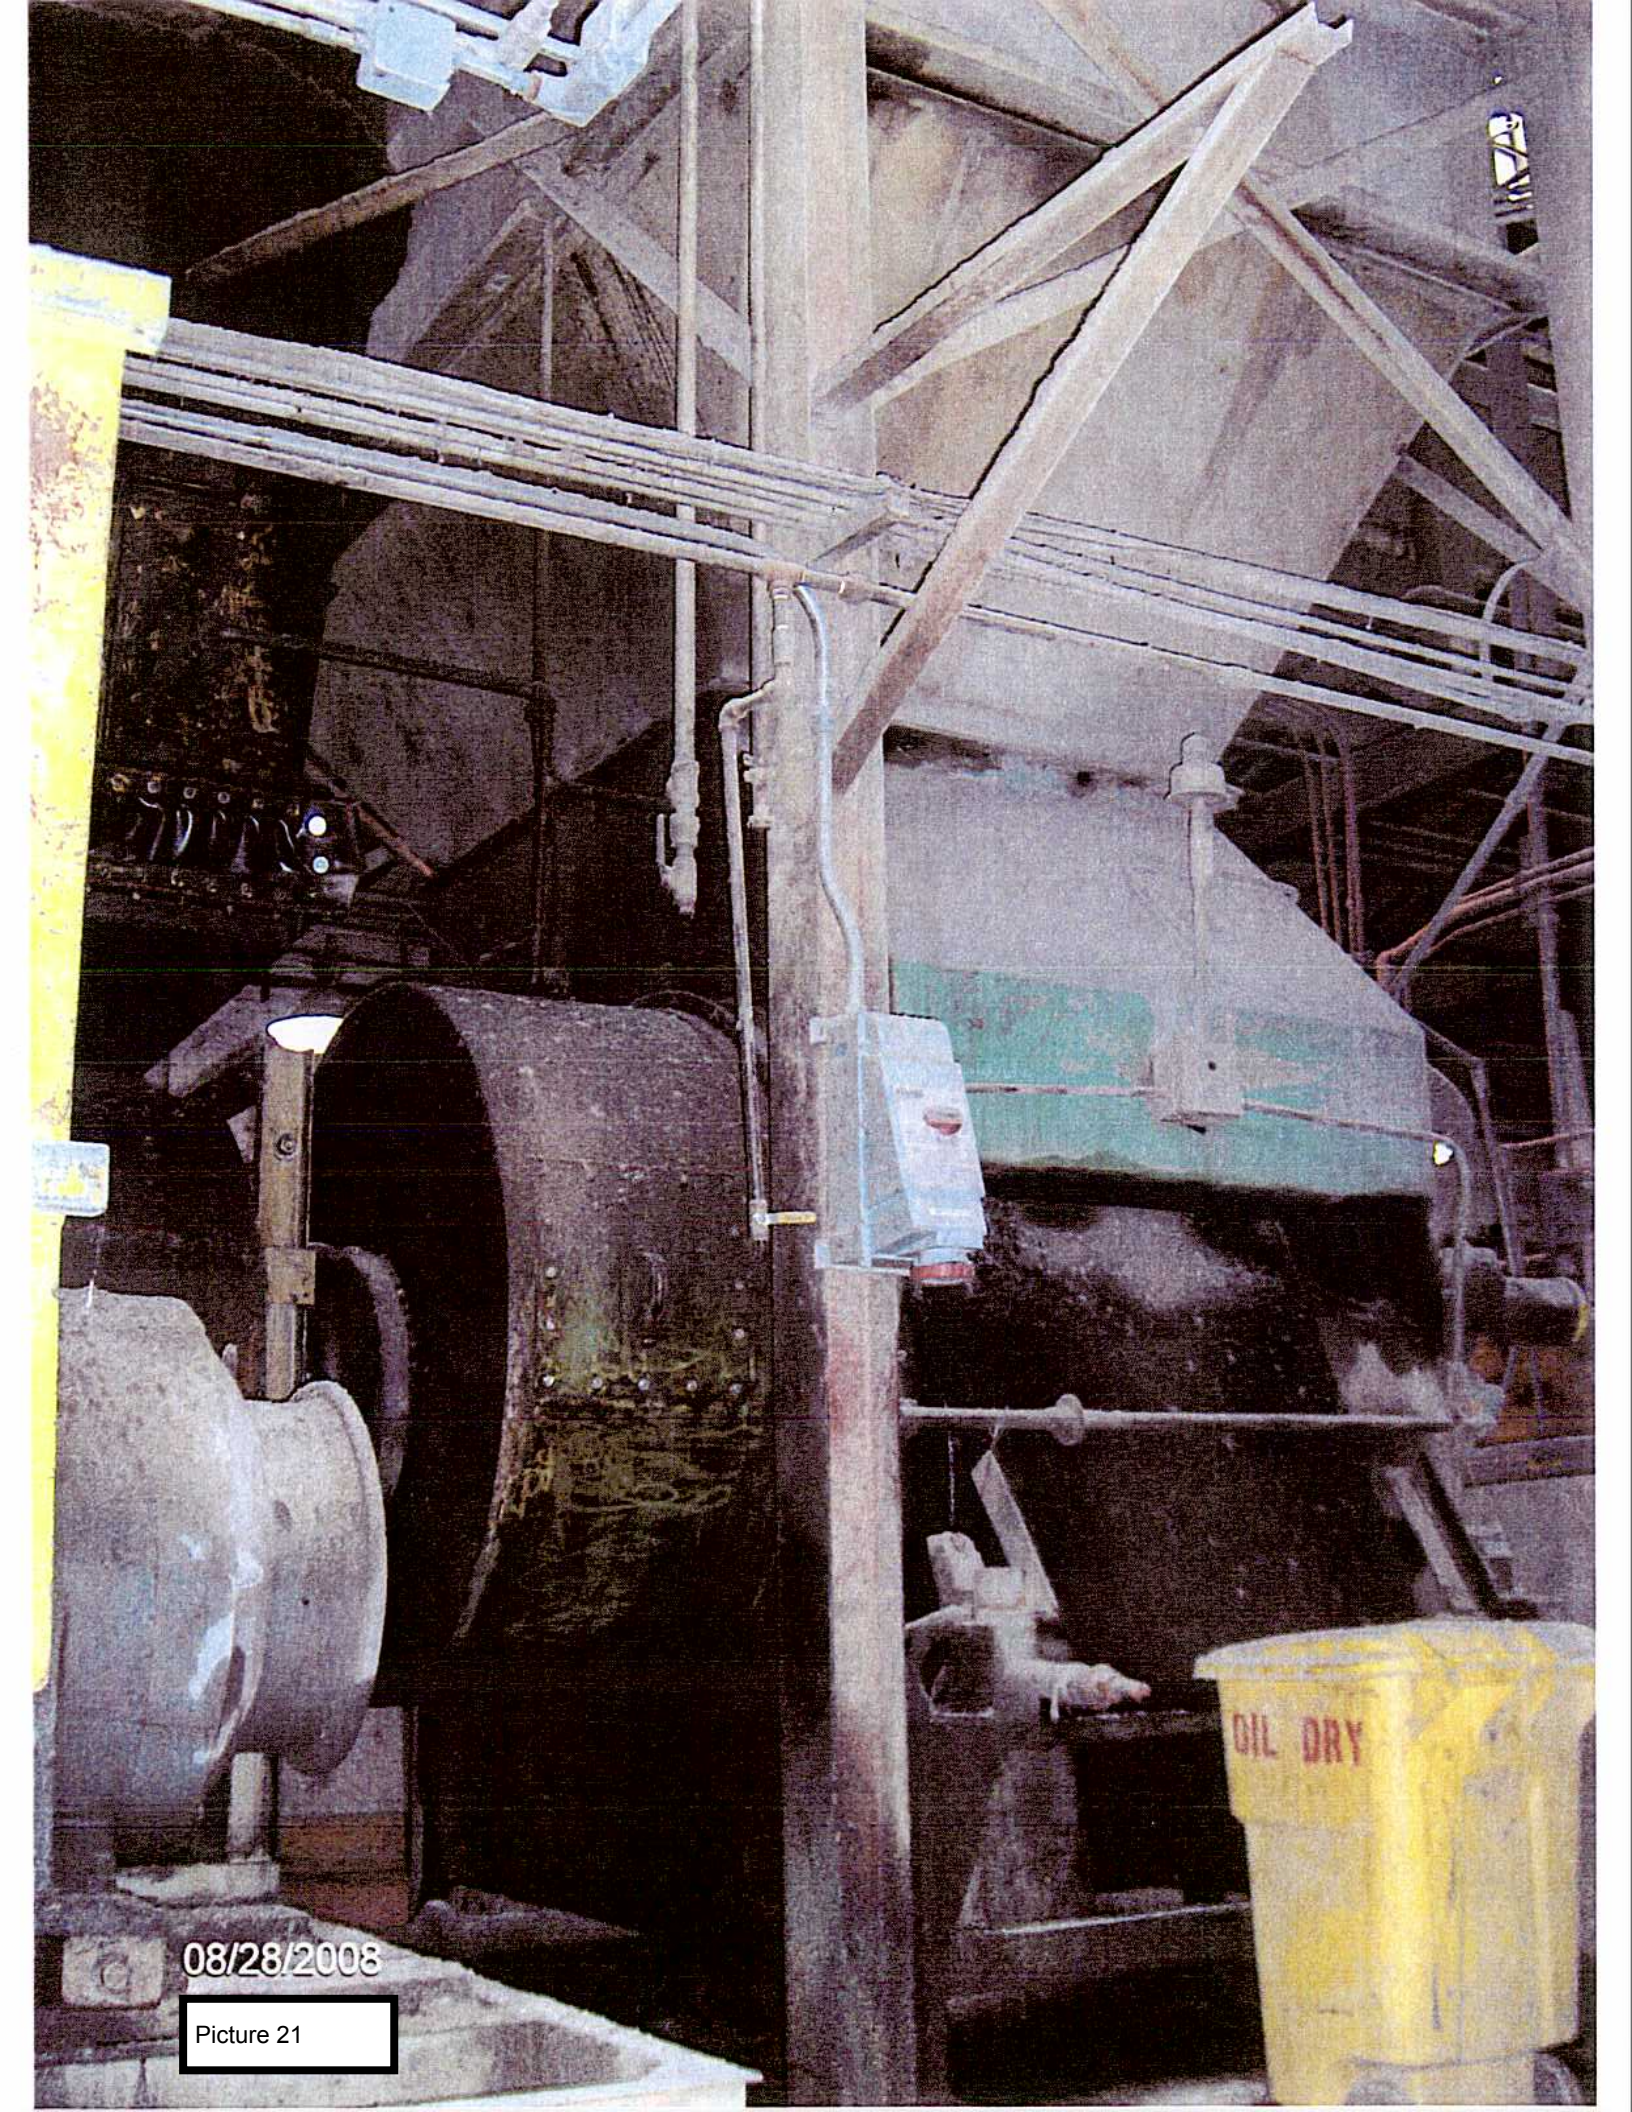
Picture 21

- Photo #19 Photo near rolled roofing line in area w/ basement.
- Photo #20 Photo of rolled roofing line.
- Photo #21 Photo of air pollution control device for rolled roofing line.

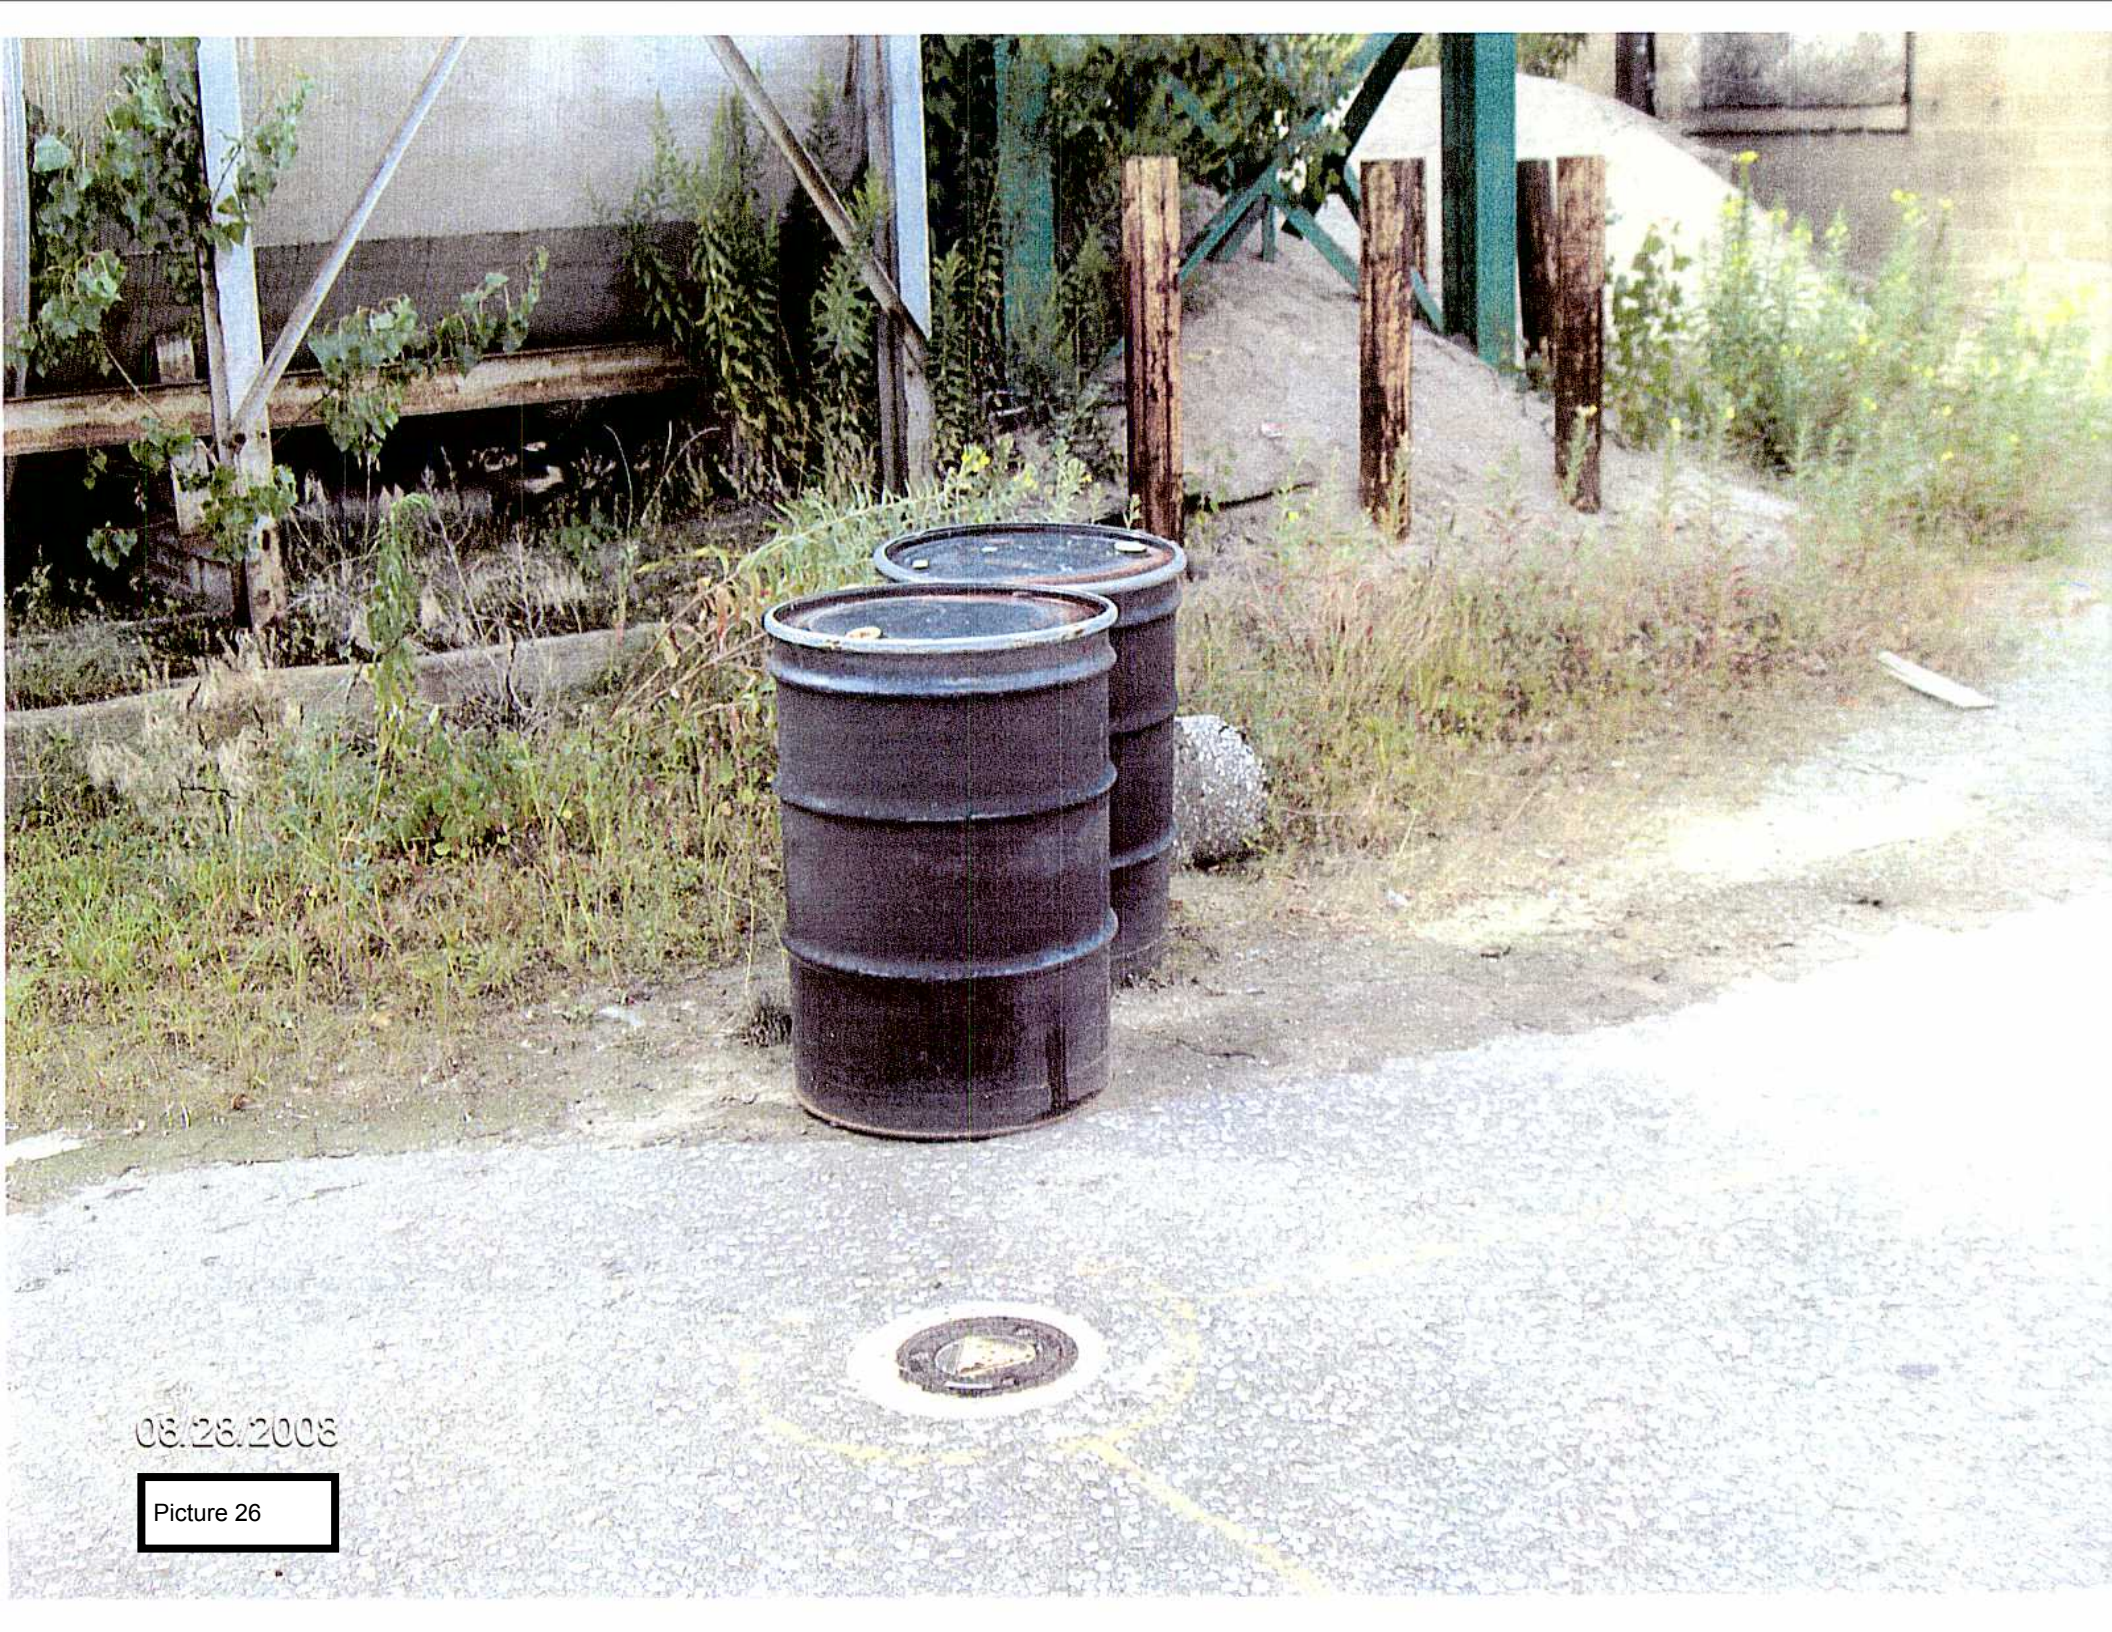
Picture 26

- Photo #25 Photo of self-seal shingle adhesive tank.
- Photo #26 View looking south of MW east of sand/slate silos. Note drums of purge water onsite.
- Photo #27 View looking northeast of waste oil (light end fraction) tank.

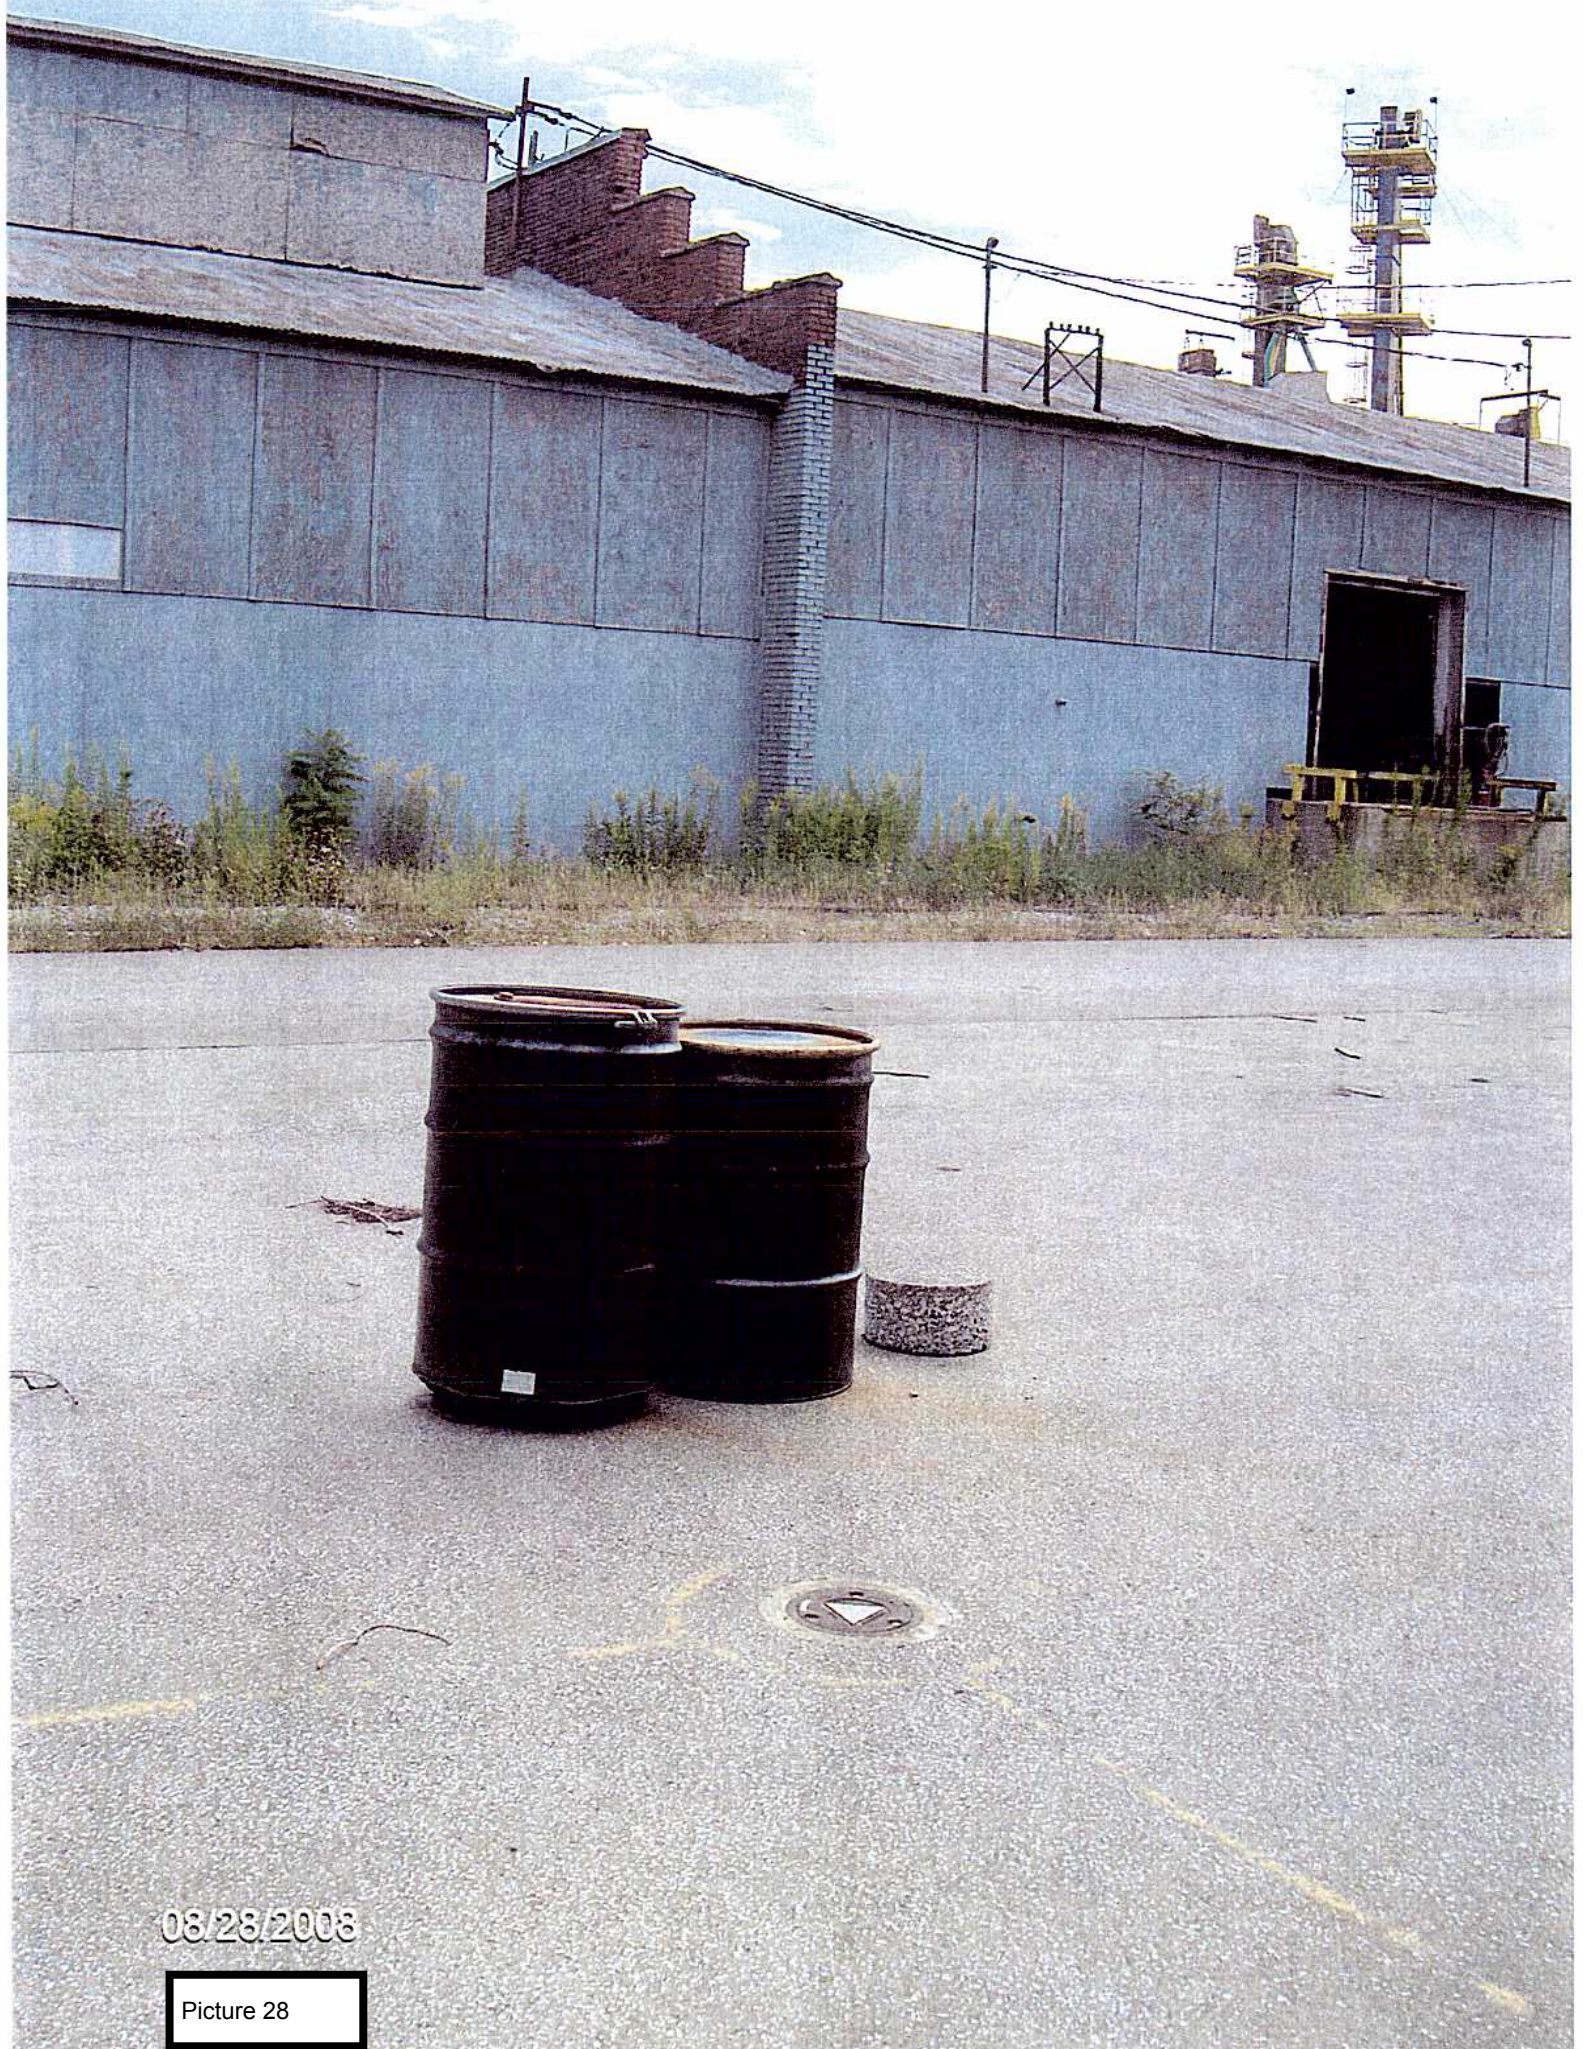
Picture 28

- Photo #28 View looking east of MW west of Bldg. 39. Note drums of purge water onsite.
- Photo #29 View looking west of MW southwest of Bldg. 1. Note drums of purge water onsite.
